Inspection Report

Pomander Avenue New Port Richey, FL 34653

Derle Parmer, HI11344

RE: Report No. 1579
Pomander Avenue
New Port Richey, FL
34653

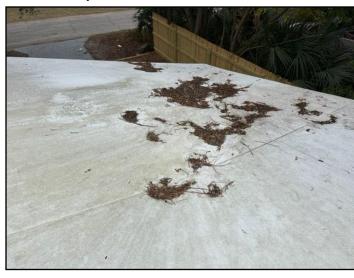
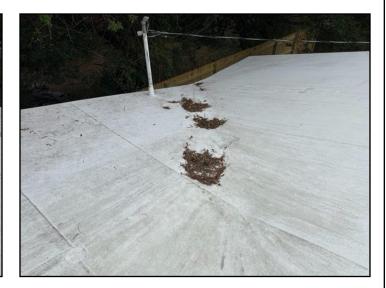
- Once all 4-POINT FAILURES are completed, provide a copy of all receipts and pictures clearly showing repairs to obtain a "Clean 4-Point". Detailed receipts and/or clear pictures may be accepted for verification of repairs at the discretion of the inspector.
- A paid Reinspection may be required at the discretion of the inspector.
- IF a copy of the failed 4-POINT is requested, there will be an additional charge required prior to completion. The repair list below clearly shows all 4-POINT FAILURES and any additional items you and your agent added.
- Send ONLY your "Clean 4-POINT" to your insurance agent. DO NOT send your full Home Inspection Report.
- 2. Condition: Debris / Limbs/ Leaves / Moss on roof will cause premature failure

Clean roof of debris. Excessive debris, primarily leaves will hold moisture and speed the deterioration of all roofing materials and/or lead to leaks. Trees should be trimmed appropriately and debris on roof should be removed regularly to prolong roof life. If your roof is shingled, do not sweep leaves as this will remove granules from shingles and speed

deterioration. Task: Clean, Time: Monthly

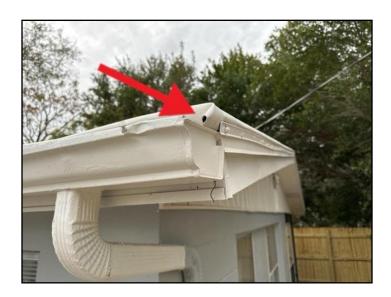
3. Condition: • Openings at seams or flashings

Task: Repair, 4-POINT FAILURE

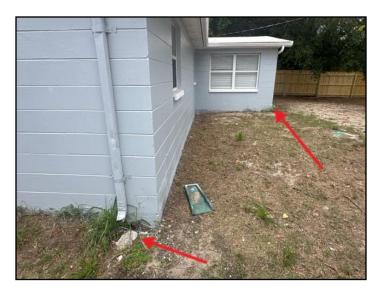
4. Condition: • Gutter downspouts discharge too close to structure

Gutter downspouts should discharge water 4-6ft from the building foundation to prevent erosion and foundation problems with settling. Extend spouts to protect structure. At a minimum, a splash block (click link above) should be placed at all downspouts to move water away from the foundation.

Task: Extend
Time: Immediate,

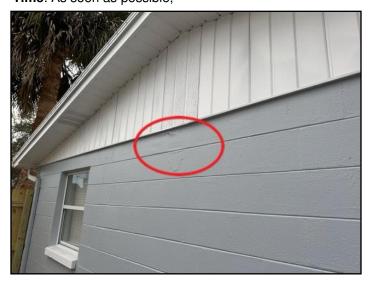
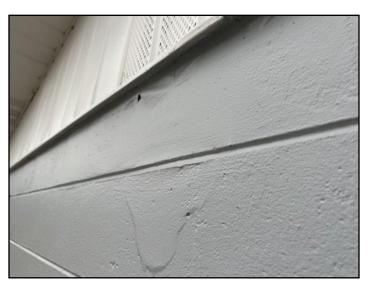
5. Condition: • Paint failing in one or more locations.

Location: Left Side **Task**: Repair,

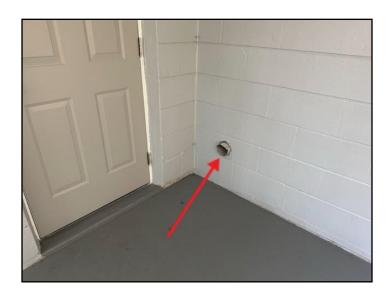
6. Condition: • Cover missing

Covers prevent pest and rodent entry into the home and clogging system.

Task: Correct,
Time: Immediate,

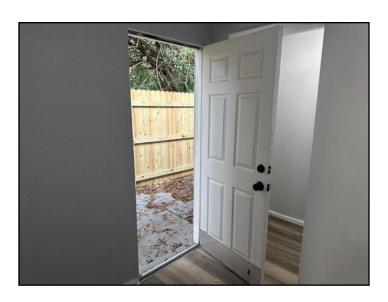
9. Condition: • Incorrect exterior door: not rated for exterior use.

Location: Left Side Task: Replace, Time: Immediate,

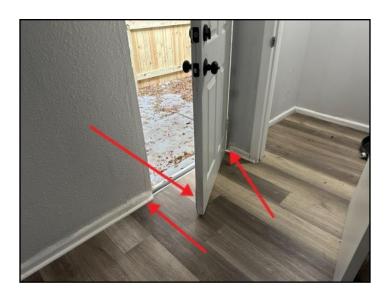
11. Condition: • Water damage on door or door frame.

Location: Left Side Task: Repair, Time: Immediate.

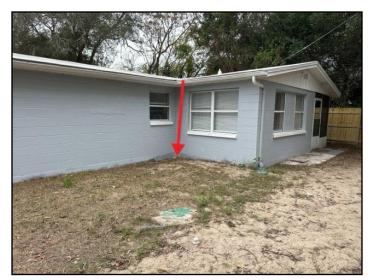
12. Condition: • Roof valley water discharge eroding soil and ponding next to foundation

Gutter splash shield missing

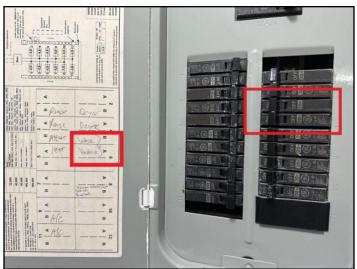
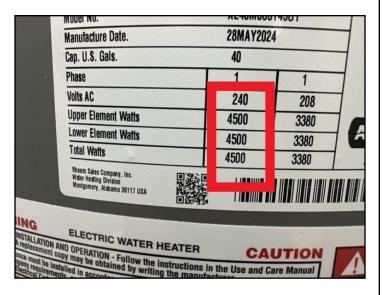
15. Condition: • Breaker undersized for equipment.

This breaker powers the water heater which requires a minimum of 30amps, which if replaced, the wire will require replacement to match the breaker size.

20 amp breaker feeding water hearter

Task: Correct,
Time: Immediate,

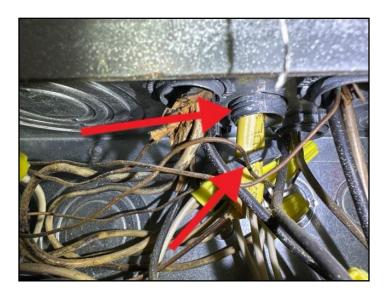
17. Condition: • Wire clamp not connected/ nut not installed on clamp

Task: Repair, 4-POINT FAILURE

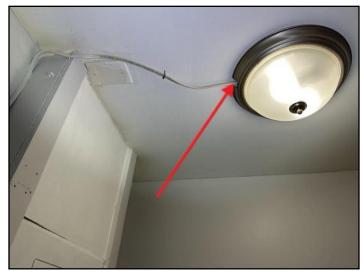
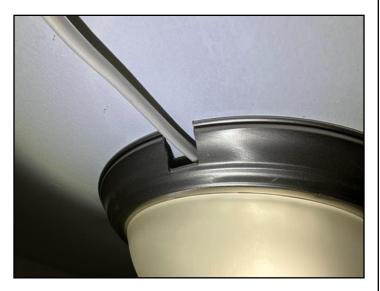
19. Condition: • Wiring not protected from physical damage- poor installation method Light incorrectly installed and does not prevent damage to wire around metal light base.

Location: Water heater closet light **Task**: Correct, 4-POINT FAILURE

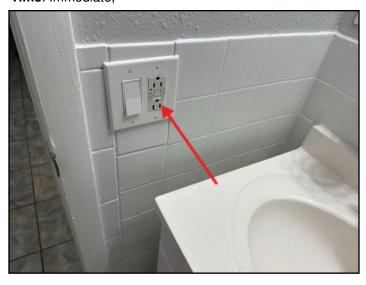
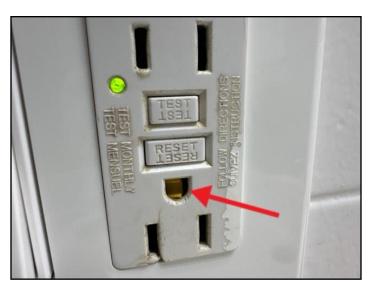
22. Condition: • Broken pin or blade in slots

Task: Replace, 4-POINT FAILURE

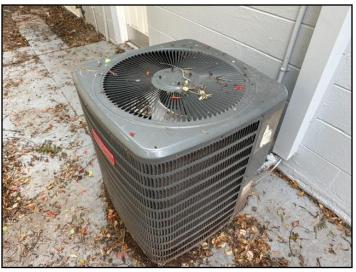
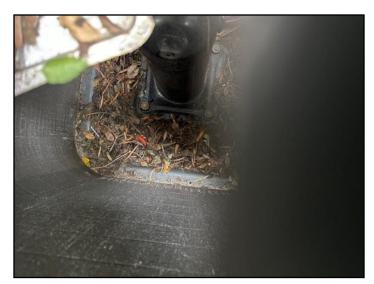
Condenser (air conditioner) is not protected from leaves and debris. Recommend condenser be covered with an appropriate screen to prevent leaves from entering condenser housing. The following link is a suggestion of the type of screen recommended and selecting your appropriate size.

Task: Protect, Clean, **Time**: As soon as possible,

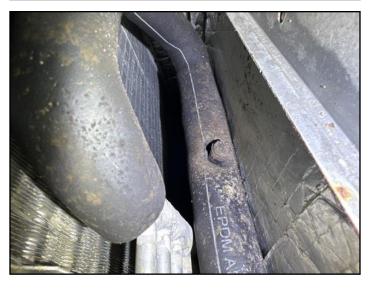
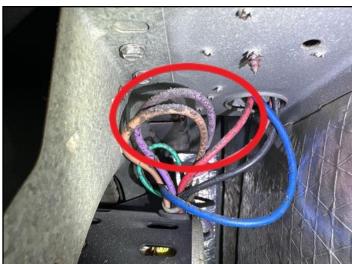
A biological/organic growth was discovered inside the HVAC system. This is common for this climate area but we do not test for biological substances as part of an inspection unless specifically requested. Recommend a thorough cleaning of all air handler components and ducts before occupying residence.

26. Condition: • Air handler has biological / organic growth inside cabinet

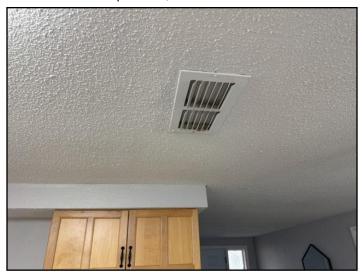
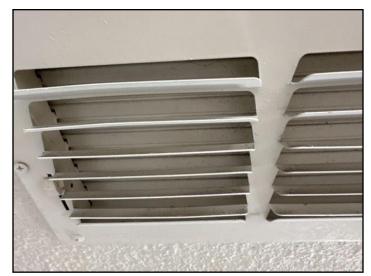
28. Condition: • Vent damaged or painted closed- will not open

Task: Repair or replace, **Time**: As soon as possible,

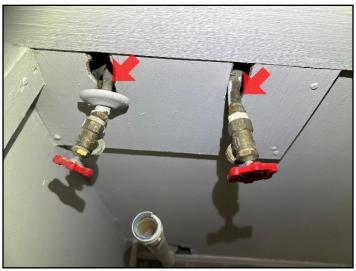
31. Condition: • Copper pipe damaged/kinked

Laundry supply pipe damaged, kinked and twisted from prior improper use/installation.

Pipe damaged- requires repair

Task: Repair, 4-POINT FAILURE

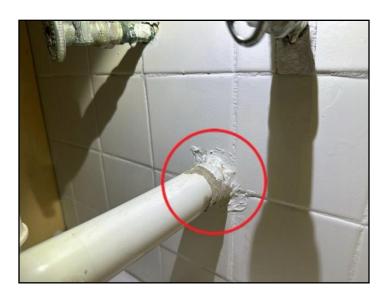
33. Condition: • Not properly connected at wall/drain

Task: Repair, 4-POINT FAILURE

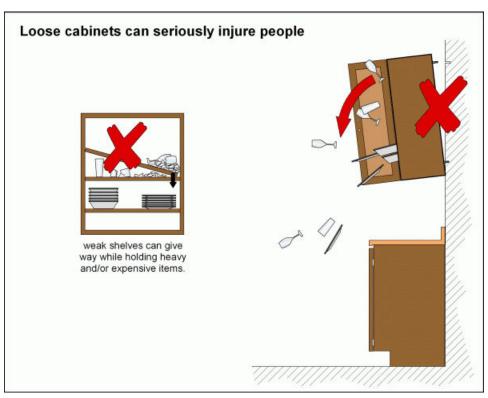
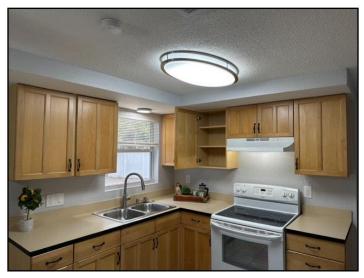
One or more cabinet(s) secured to wall without washers on the screws. Replace with proper screws or remove screws one at a time and add washers to prevent cabinet from falling when loaded.

Location: Kitchen Task: Repair, Time: Immediate,

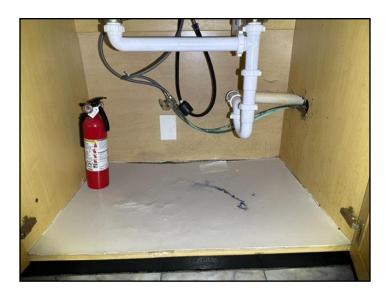
40. Condition: • Water damaged cabinet- organic substance present

Possible Organic substance present due to previous water damage under cabinet. All effected materials should be replaced and framing cleaned. Be advised, additional damaged material may be hidden and only visible when opened for repair.

Location: Kitchen **Task**: Replace,

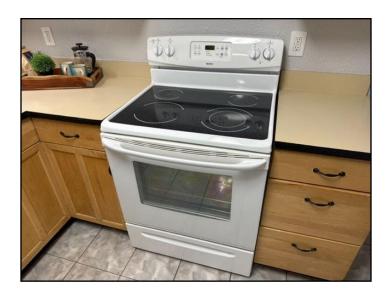
42. Condition: • Anti-tip device missing

Anti-Tip devices mount under the stove/range and prevent it from tipping over causing severe injury. Recommend installing an anti-tip device to protect occupants.

Location: Kitchen
Task: Correct, Protect,
Time: Immediate.
