# Inspection Report

South Beverly Avenue  
Tampa, FL 33609

Tuesday, July 1, 2025

RE: Report No. 1630  
South Beverly Avenue  
Tampa, FL  
33609

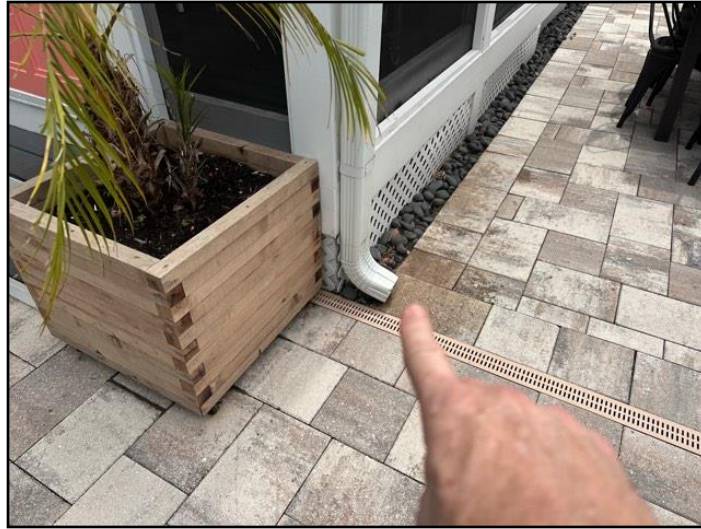
**4. Condition:** • [Gutter or Downspout discharge too close to home](#)

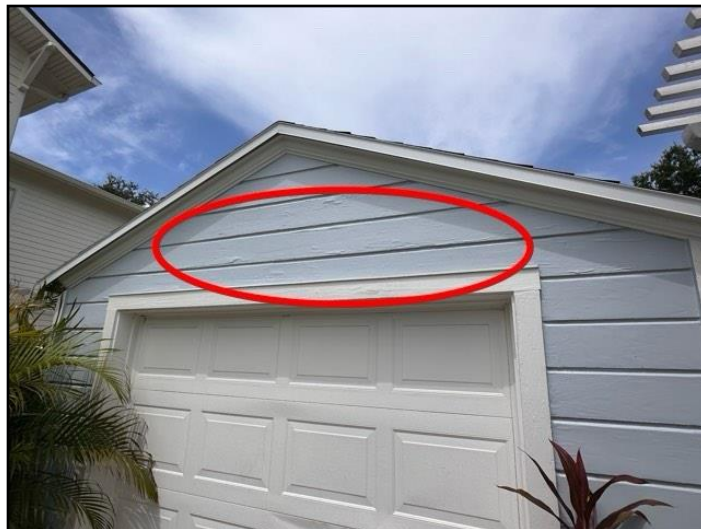
**5. Condition:** • Paint failing in one or more locations.

**Task:** Repair,

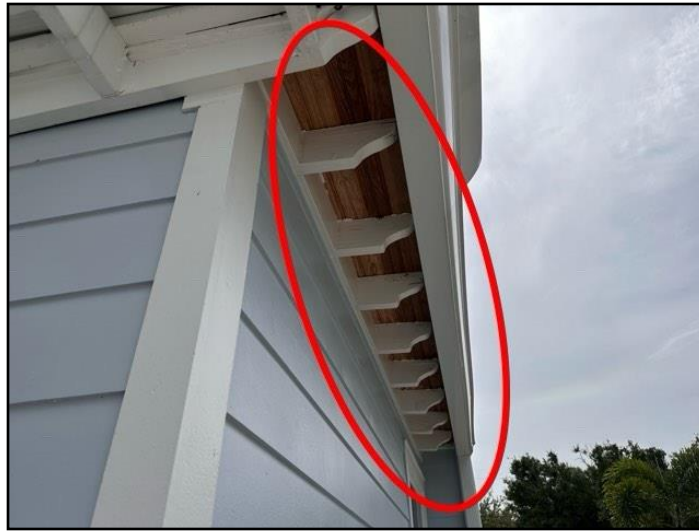
**6. Condition:** • Paint or stain needed

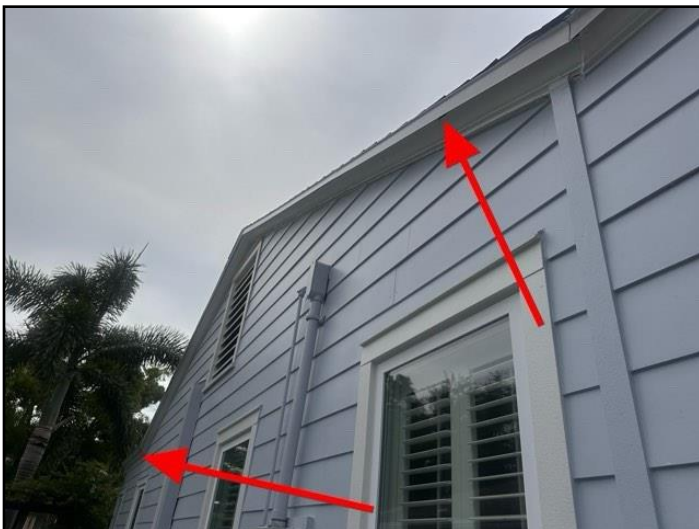
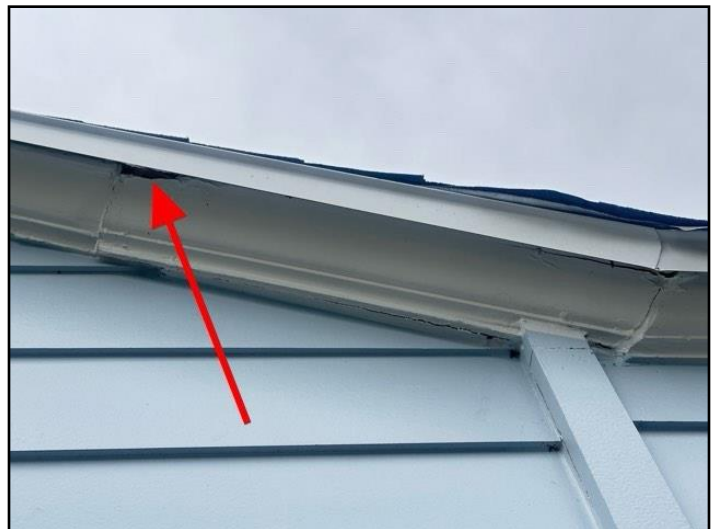
**Condition:** • Water damaged

One or more areas around home are water damaged. All areas of trim and uncaulked seams for siding should be evaluated for water intrusion and repaired as needed. Further hidden damage may be found when removing materials for repair.

Wood framed homes of this age typically have water damaged siding as well as insect damage. Recommend a WDO inspection before end of inspection period.

### **7. Condition:** • Water damaged

**Task:** Repair or replace, Recommend WDO Inspection

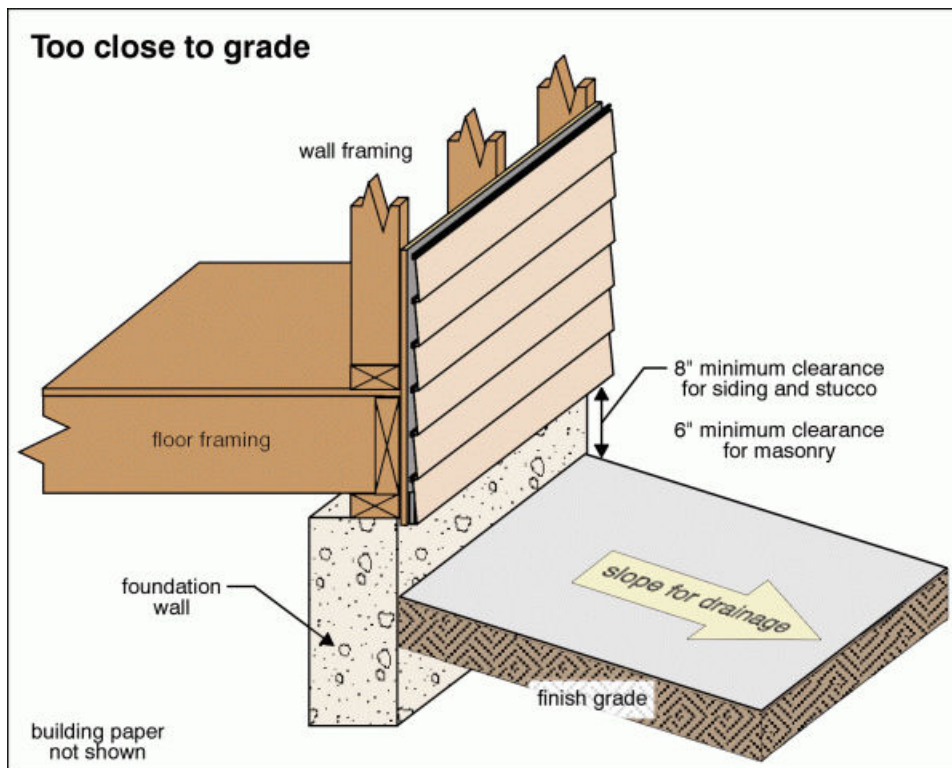
**Condition:** • Too close to grade or wood/soil contact

Wood framed wall in contact with soil will allow moisture and insect damage over time. Water damage present in one or more locations. Remove soil at least 4-6 inches to protect structure.

Hidden damage may be present and only seen when materials are removed for repair.

**10. Condition:** • Too close to grade or wood/soil contact

**Task:** Repair, Protect,

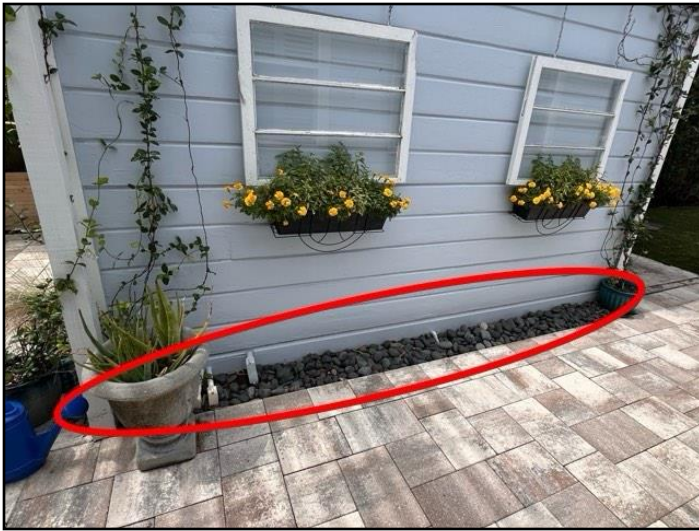
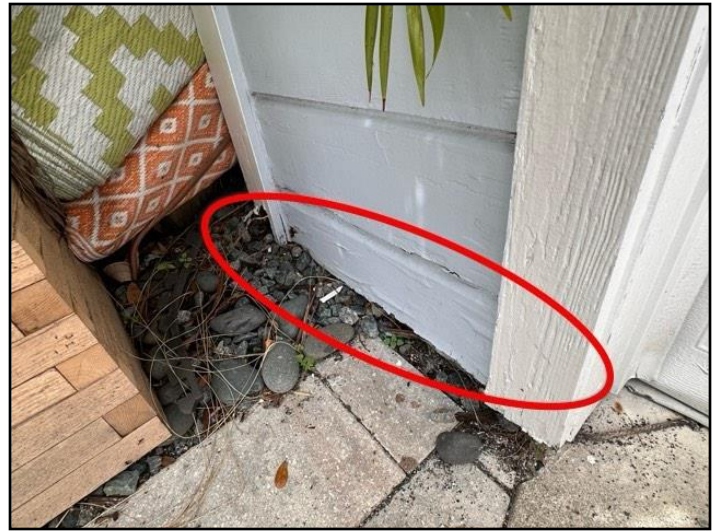
**11. Condition:** • Sloped toward home in one or more location

**Task:** Correct, Protect,

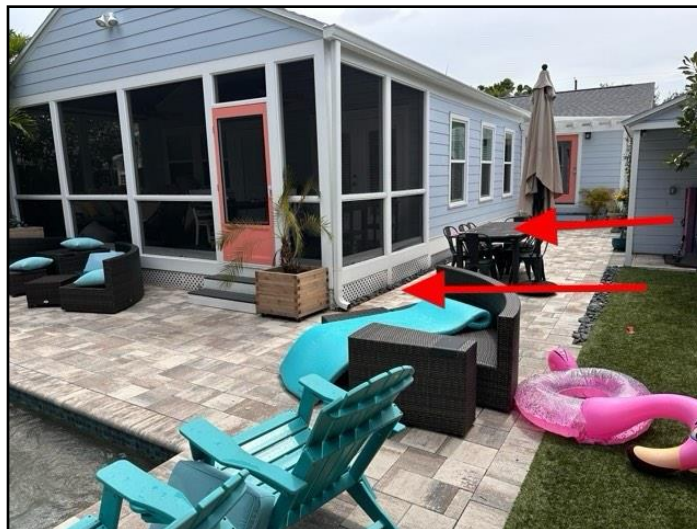
**12. Condition:** • Settlement

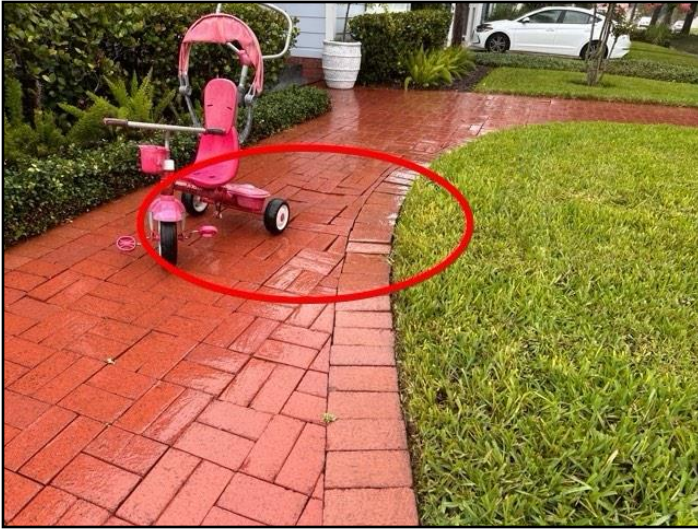
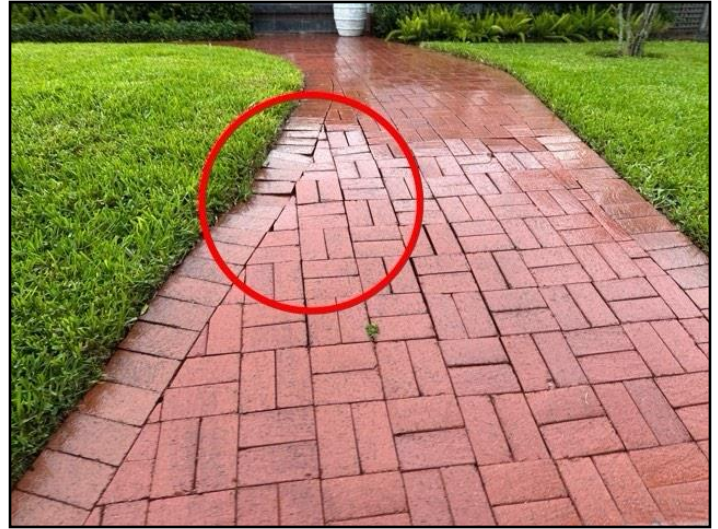
**13. Condition:** • Damage

**Task:** Repair or replace,

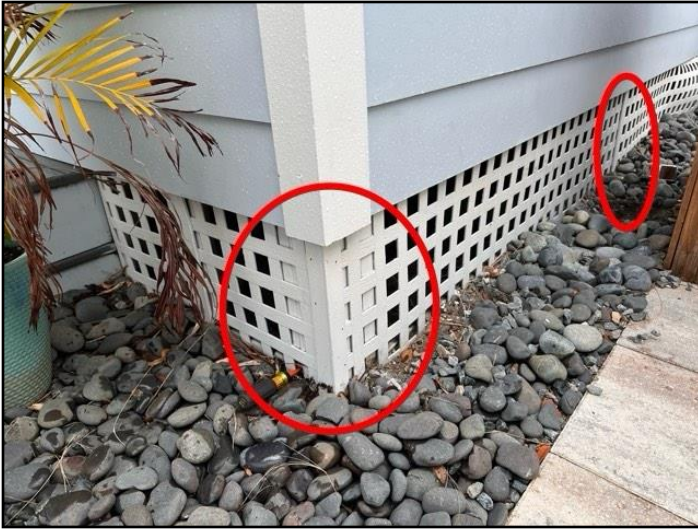
*Wood supports water damaged/rotten*

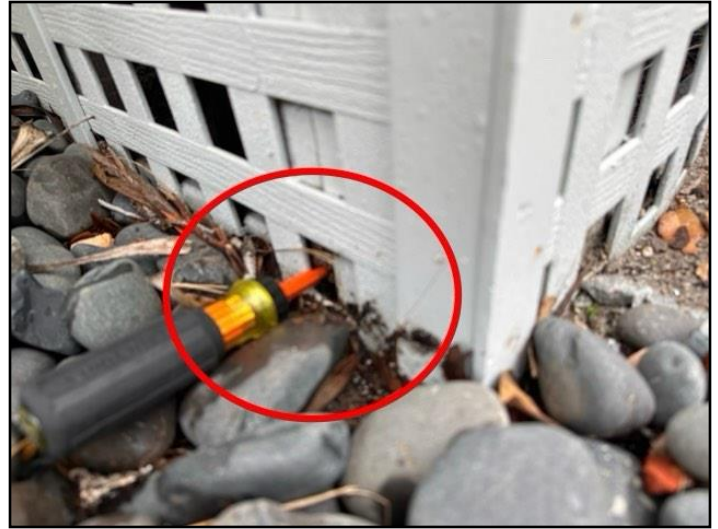
*Rotten supports*

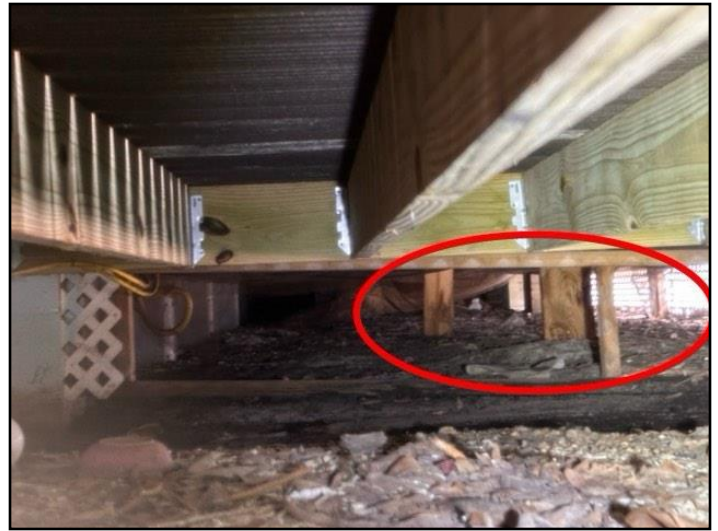
*Multiple single board supports present*

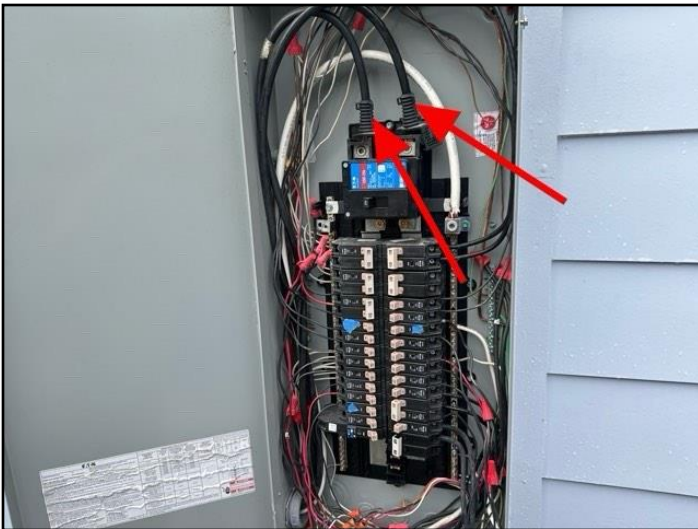
**Condition:** • Inadequate service size for this home. Recommend further evaluation by a licensed professional electrician to determine proper size wire based on a complete load calculation.

*Service wire possibly undersized*

**Task:** Further review by qualified expert prior to end of inspection contingency period, 4-POINT FAILURE

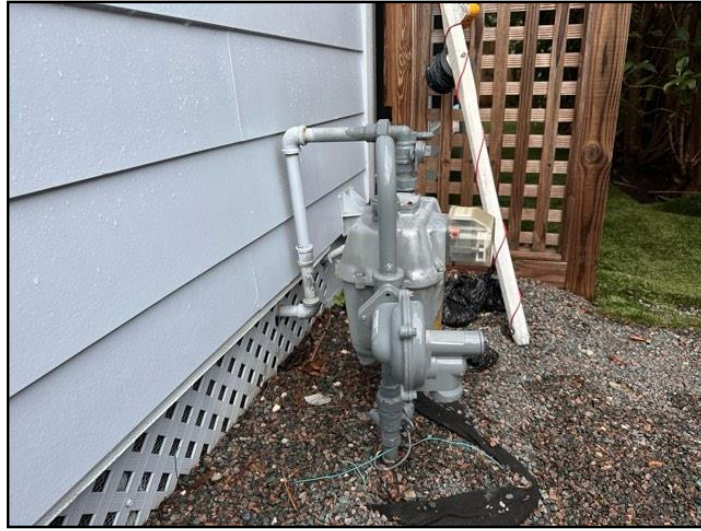
Gas systems are required to be bonded to the electrical system. This bond can be either at the meter or another location within the home. A visible bonding connection was not found during the inspection and should be verified to be properly bonded to the electrical system for safety of occupants and structure.

NOTE: This home is piped with a CSST gas piping and may be bonded in a location that is not visible. Recommend this be verified and corrected as needed by a qualified professional.

**19. Condition:** • Bonding (for Gas Piping) - missing or not visible. Recommend evaluation by a licensed professional electrician or gas company to determine bonding.

**Task:** Repair, 4-POINT FAILURE

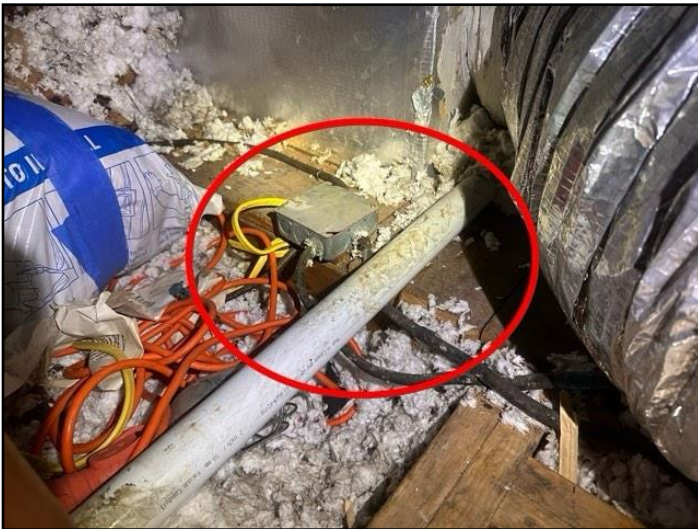
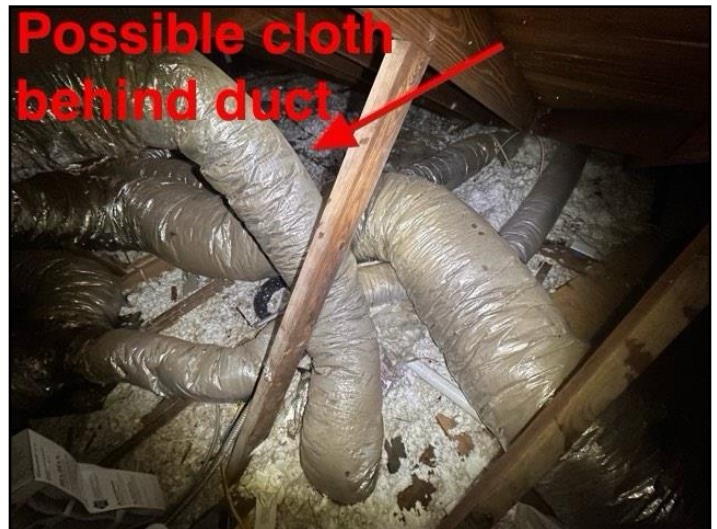
Antiquated (cloth wrapped rubber insulated) wire present. This wire deteriorates and cracks, exposing the conductor and increases the risk of fire hazard.

**20. Condition:** • Antiquated cloth wrapped wire present- consider replacement

**Task:** Further evaluation by licensed professional,

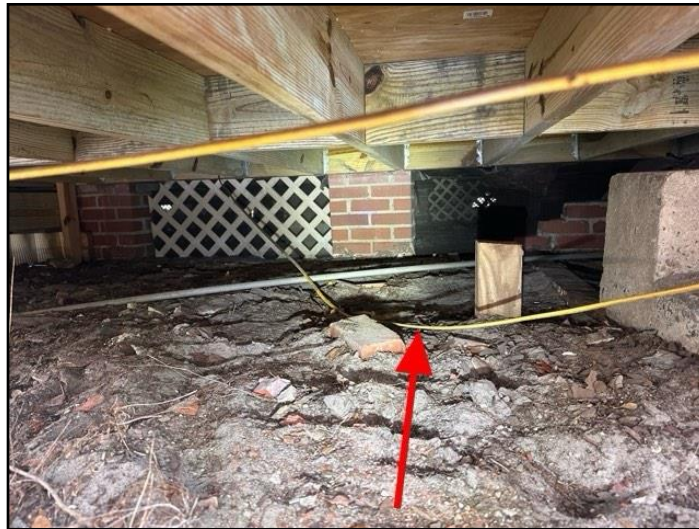
**21. Condition:** • Wires in contact with ground and not secured properly to structure

**Task:** Repair, 4-POINT FAILURE

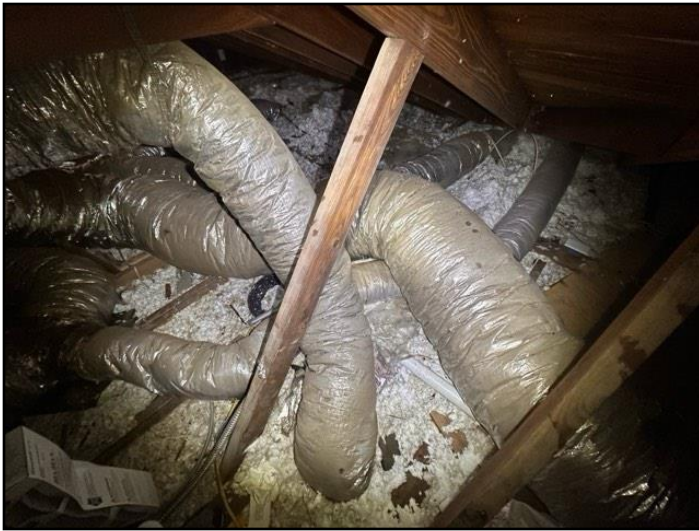
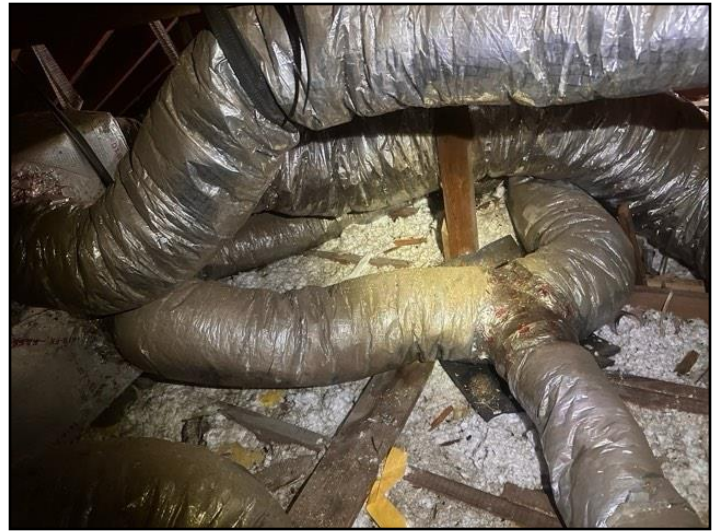
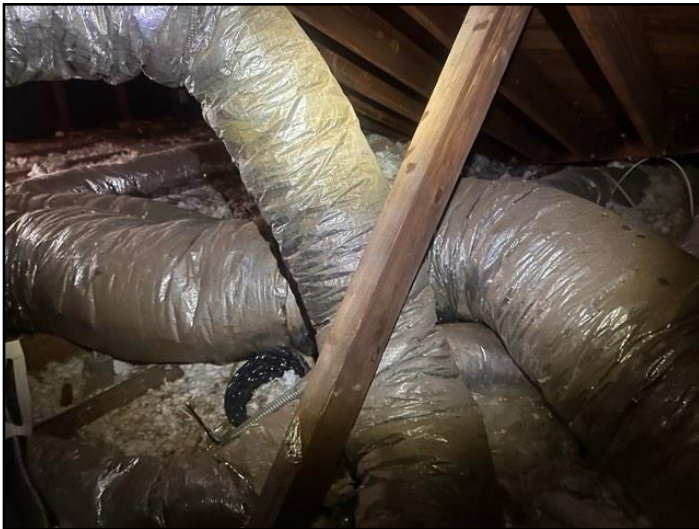
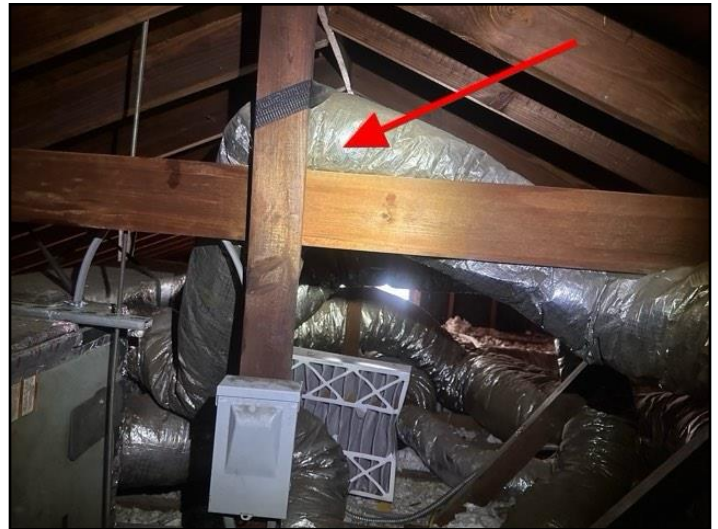
Flex Ducts routed in extreme angles effect the efficiency of air flow and overall effectiveness of HVAC system and the overall conditioning of the living space. Excess supply & return duct length should be trimmed and routed as straight as possible to maximize efficiency and reduce wear on the system from prolonged operation. Mastic should be used on all joints to prevent leakage.

**28. Condition:** • Duct routed in extreme angle or too long- Incorrect installation method

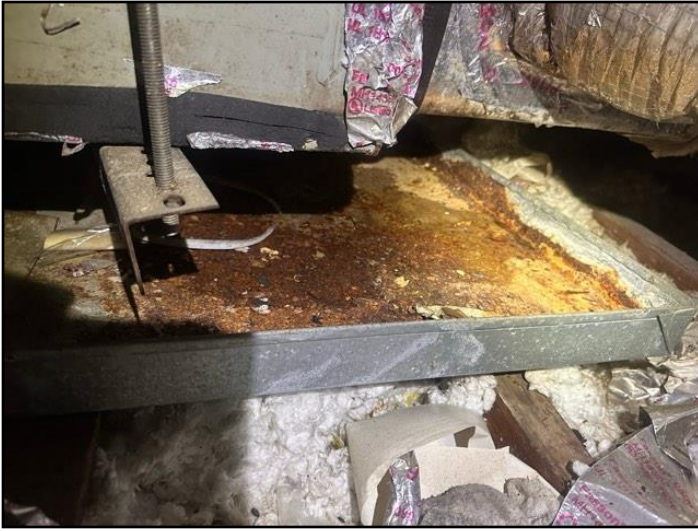
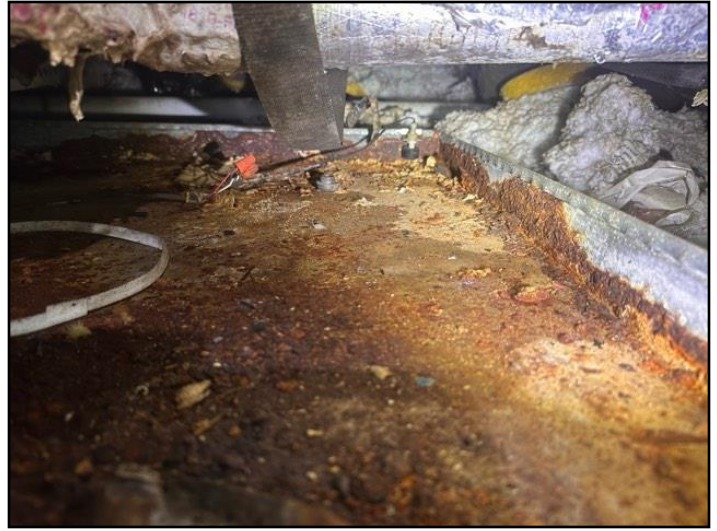
**29. Condition:** • Condensation/ Overflow drain pan has excessive corrosion or leaking  
Excessive corrosion will lead to leaks and water damage to structure.

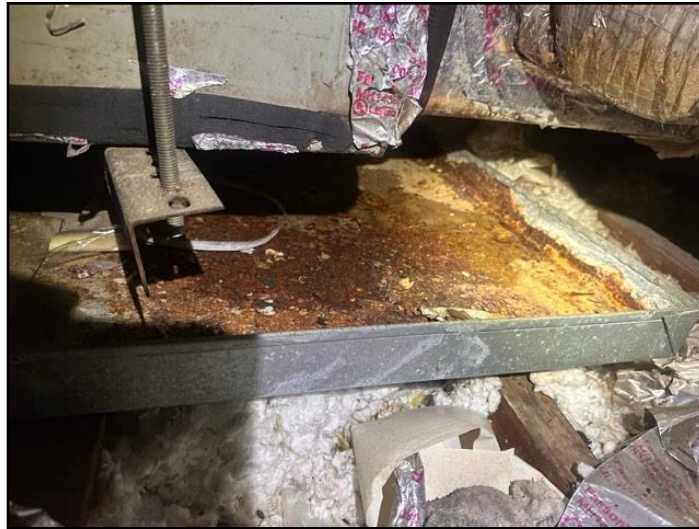
**30. Condition:** • Condensation overflow pan not level

Out of level or poorly supported drain pans in an attic will cause water damage if not repaired.

**Task:** Repair,

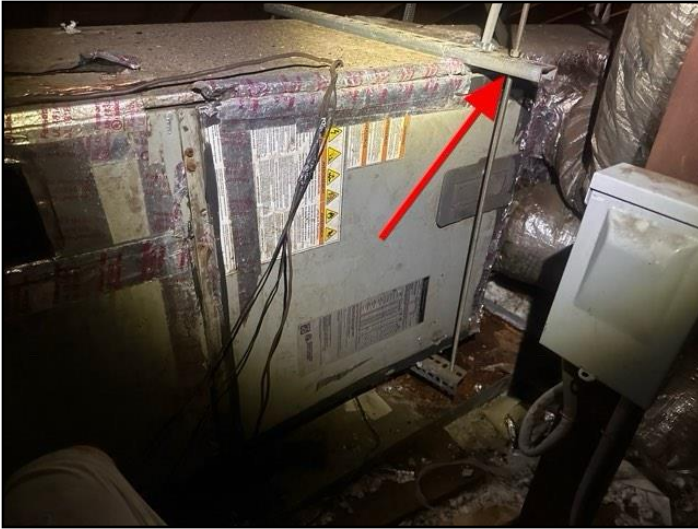
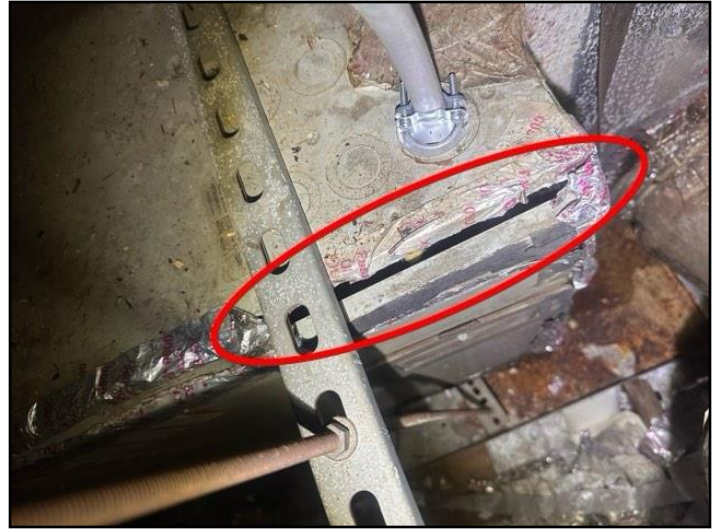
**31. Condition:** • Air handler cover not secured and pulling unconditioned attic air into system or leaking into attic.

Due to the age, recommend replacement.

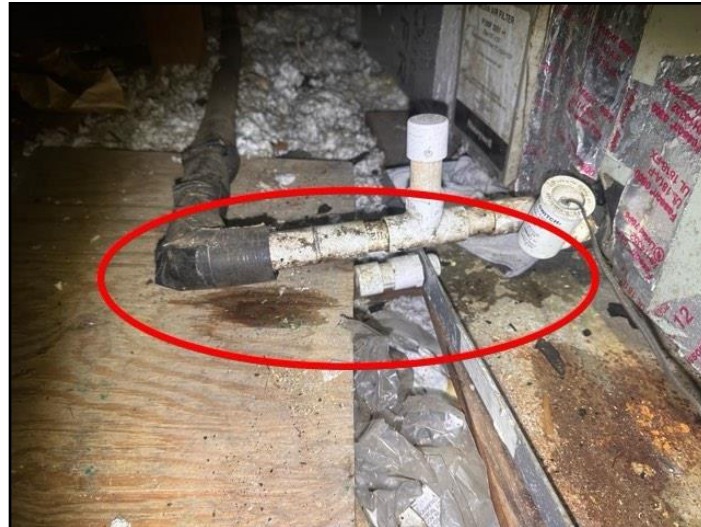
**32. Condition:** • Air handler condensation line not insulated and dripping onto structure. This antiquated system (15yo) should be replaced to prevent damage to the structure.

**Task:** Repair, 4-POINT FAILURE

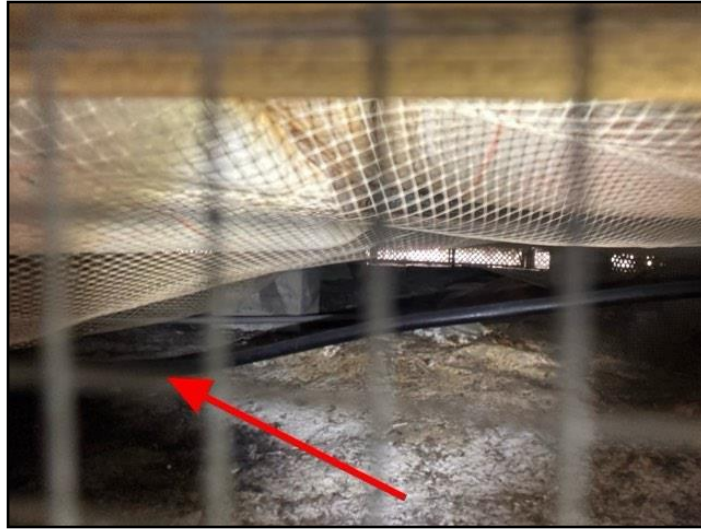
**Condition:** • Corrugated Stainless Steel (CSST) gas pipe unsupported and/or routed across ground CSST gas pipe installed incorrectly in contact with soil. Manufacturers require this piping to be secured to the structure to prevent damage or corrosion. Although this is sleeved it should be attached to the structure.

**35. Condition:** • Corrugated Stainless Steel (CSST) gas pipe unsupported and/or routed across ground

**Task:** Repair, 4-POINT FAILURE

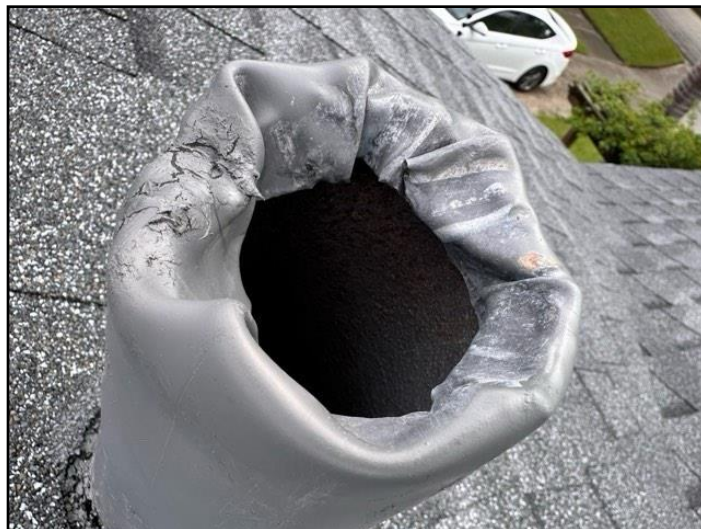
Cast iron drain/vent piping is present in this home. This material is known to corrode from the inside out, fail over time and cause repeated backups and damage to structures. Although PVC pipe may be connected at some point in the system, many times it may be connected to the original cast iron pipe.

**36. Condition:** • Cast iron pipes present - Recommend drain scope

A reliable sewer scope with video and a recommendation can be obtained by calling Curt Arnold (813) 469-7443.

**Task:** Further review by qualified expert prior to end of inspection contingency period

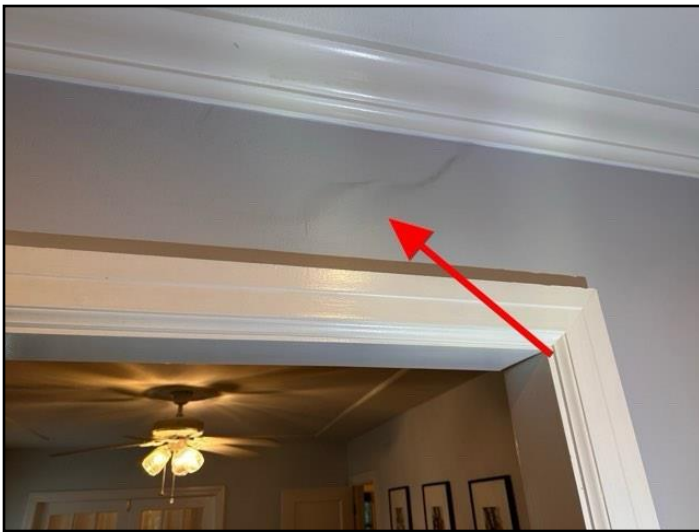
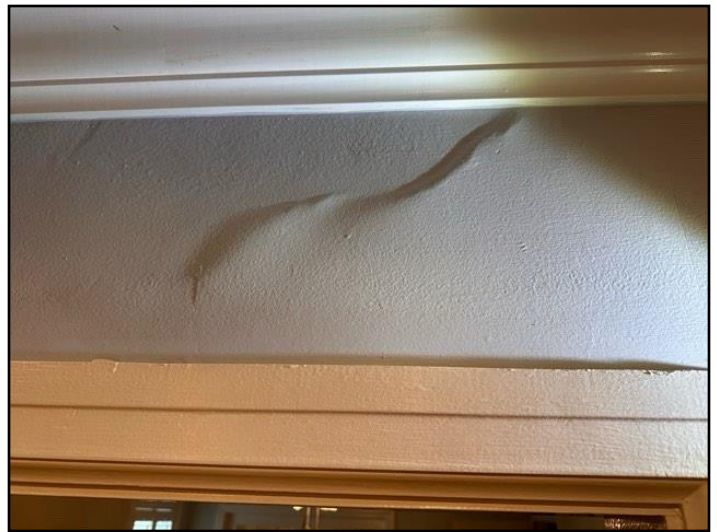
**39. Condition:** • Paint failing in one or more locations

**Task:** Repair,

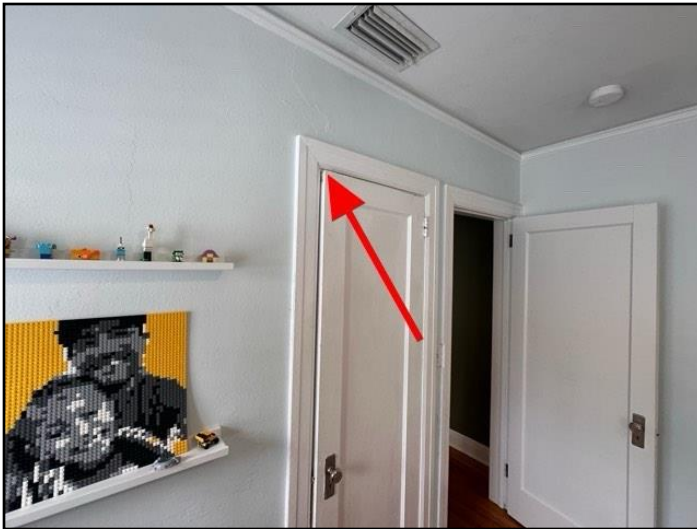
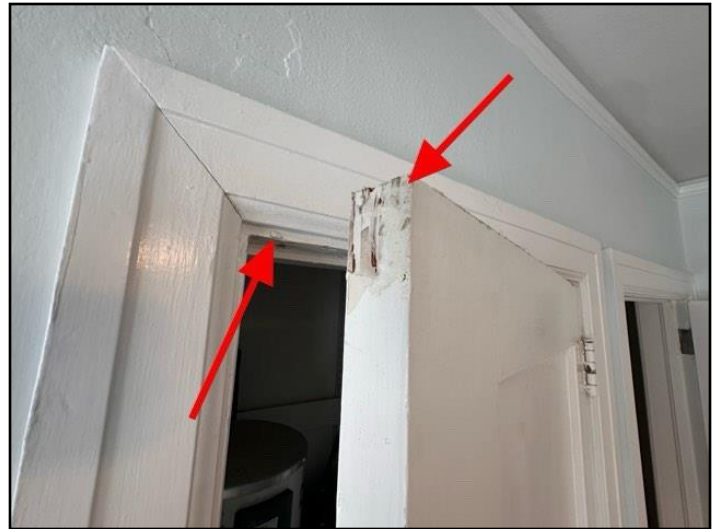
**40. Condition:** • [Door binds](#)

**Task:** Repair or replace,
