# Inspection Report

#### Riverston Avenue  
Wesley Chapel, FL 33545

RE: Report No. 1637  
#### Riverston Avenue  
Wesley Chapel, FL  
33545

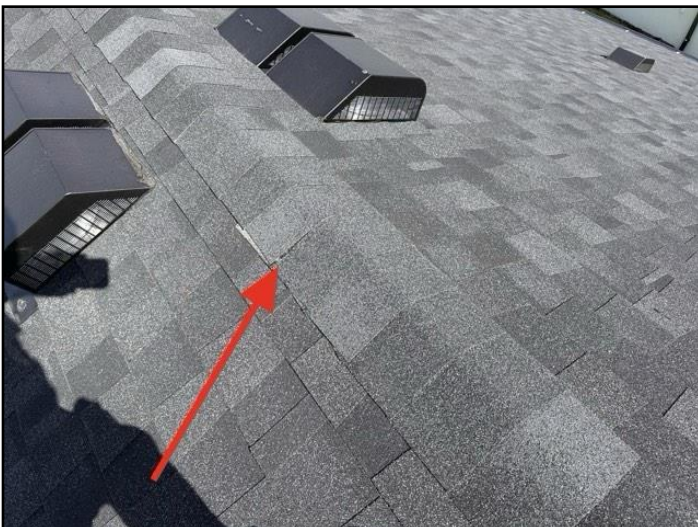
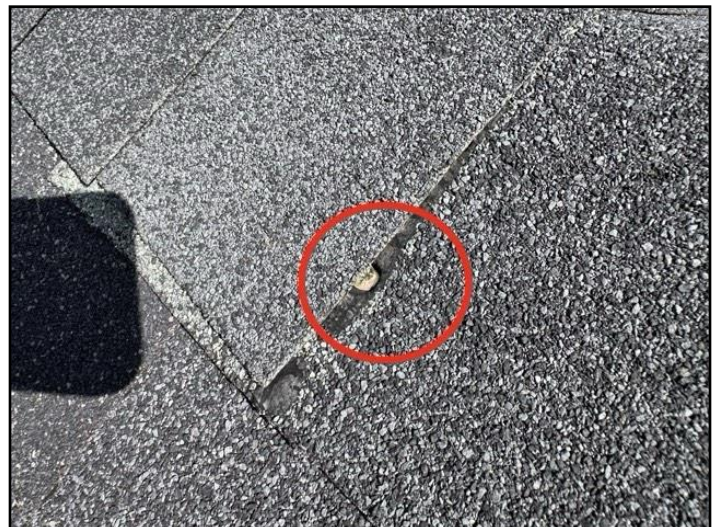
**1. Condition:** • Exposed fasteners should be sealed with appropriate roofing sealant to protect structure.

Pictures provided are only a representation and may not show every instance of this defect. A full evaluation for this and other defects should be completed and all necessary repairs completed by a qualified professional.

**Implication(s):** Chance of water damage to structure, finishes and contents

**Location:** Top ridge at front

**Task:** Repair or replace,

**Time:** Immediate,

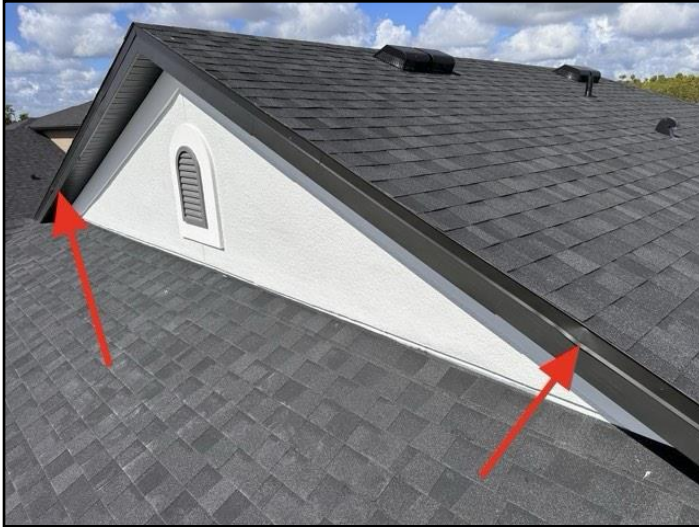
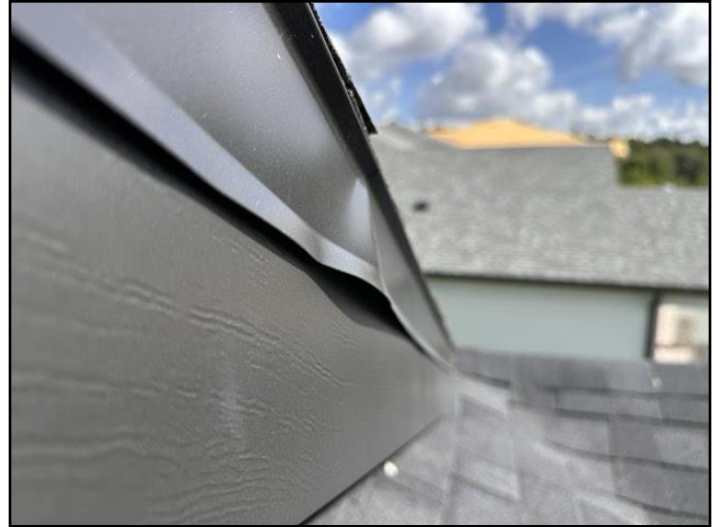
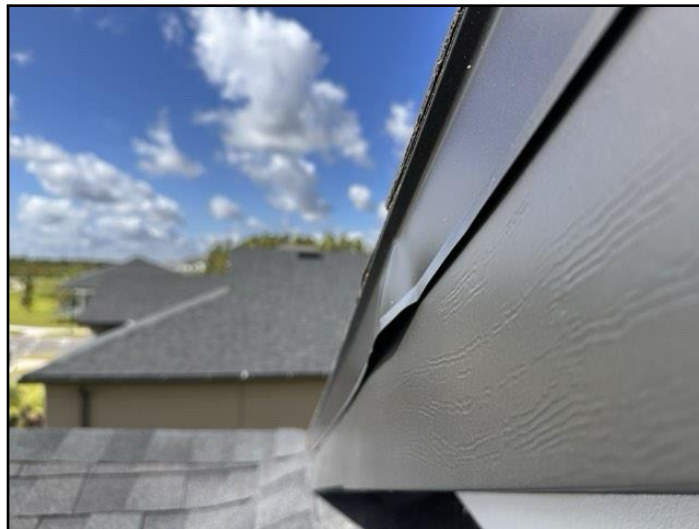
**2. Condition:** • Damaged drip edge

**Task:** Repair or replace,

**Time:** Immediate,

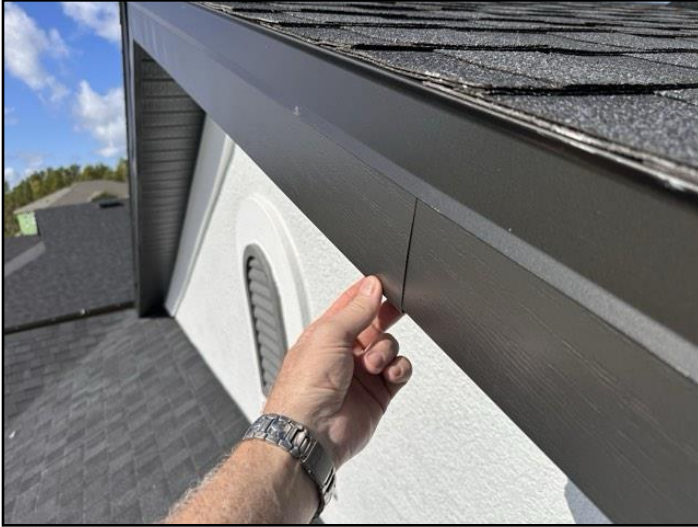
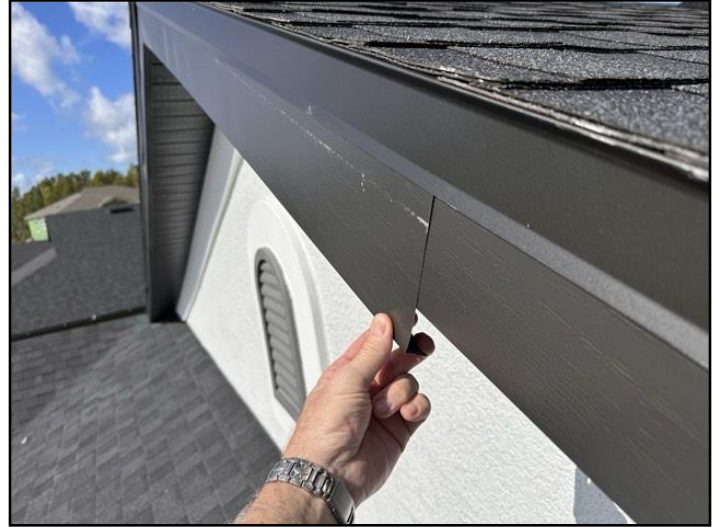
**3. Condition:** • Loose or missing pieces

**Implication(s):** Chance of water damage to structure, finishes and contents | Chance of pests entering building

**Task:** Repair or replace,

**Time:** Immediate,

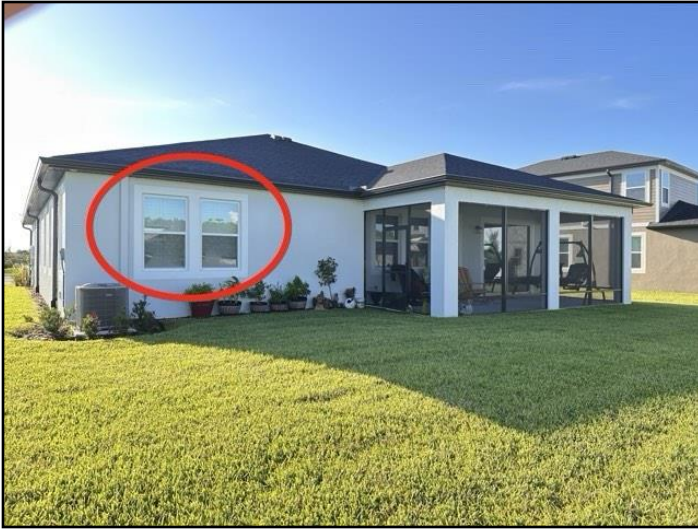
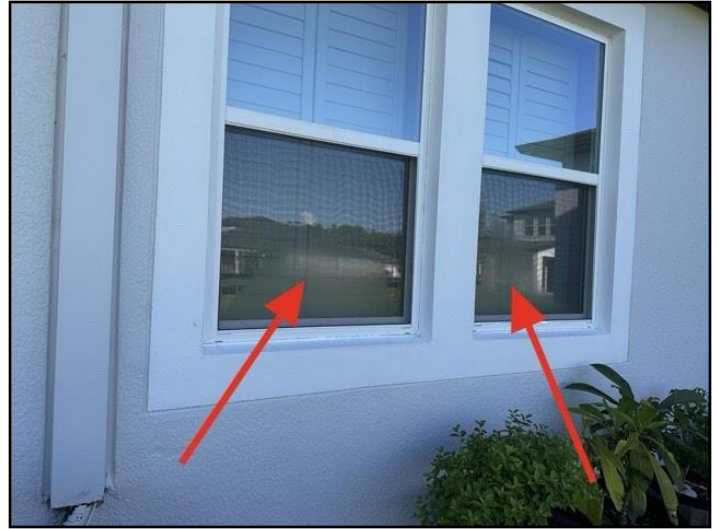
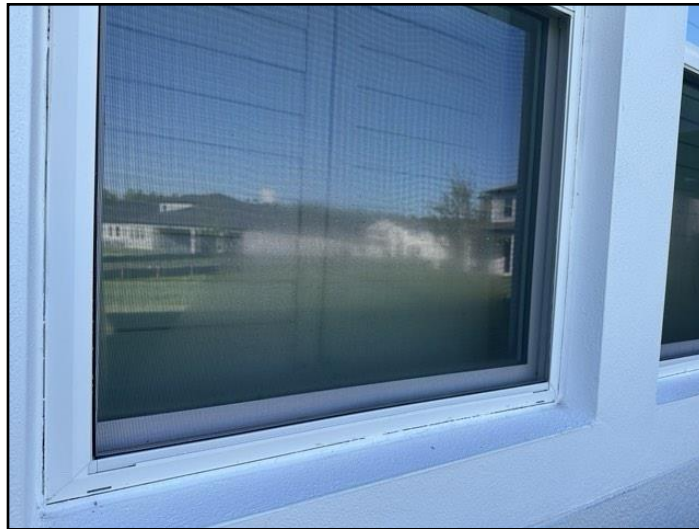
**5. Condition:** • [Lost seal on double or triple glazing](#)

One or more window lost seal. Hazing and/or condensation of this nature inside the window panes is an indication of a lost seal allowing the inert insulating gas to escape. A lost seal is not a major defect to the window and any reduction of efficiency of the HVAC system is negligible. Recommend addition of a tint to windows to improve efficiency in the home.

**Task:** Replace,

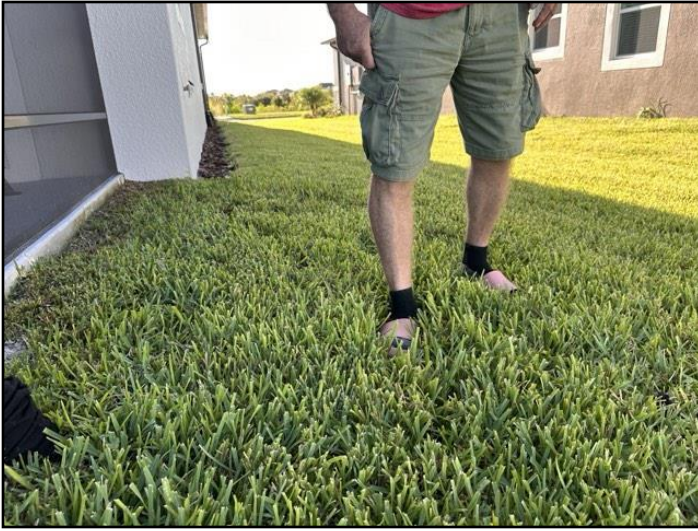
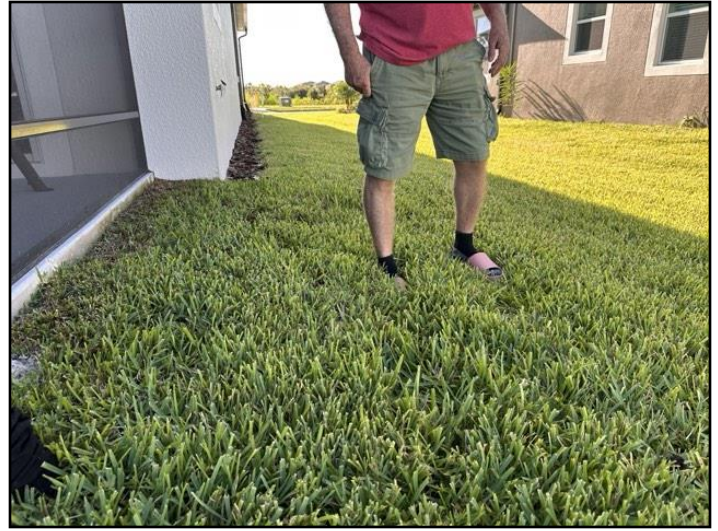
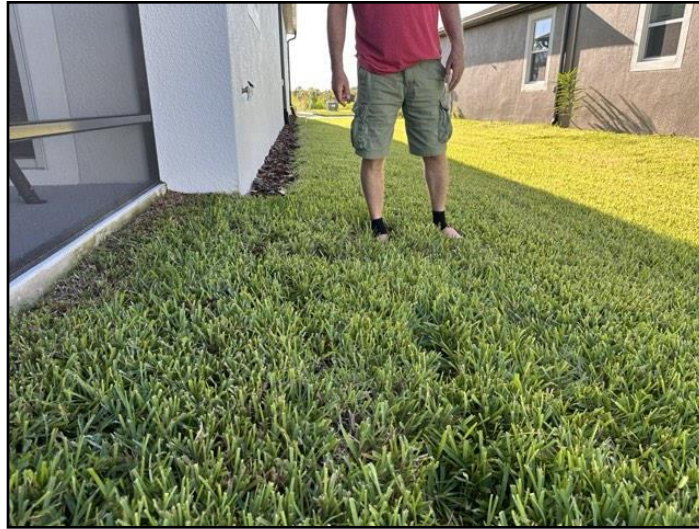
**6. Condition:** • Multiple areas around the home's yard where trip hazards are present. Multiple spots where the sod was placed improperly with gaps that are now severe trip hazards and should be properly filled/leveled.

This is hazard to older individuals or anyone with lower extremity issues or previous surgeries.

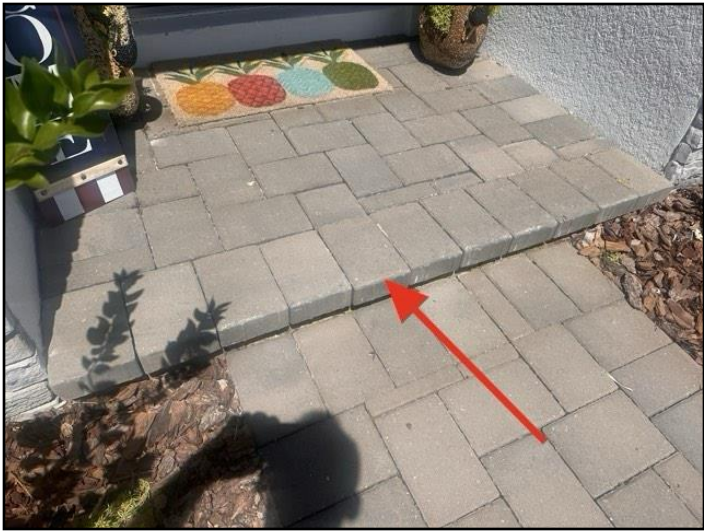
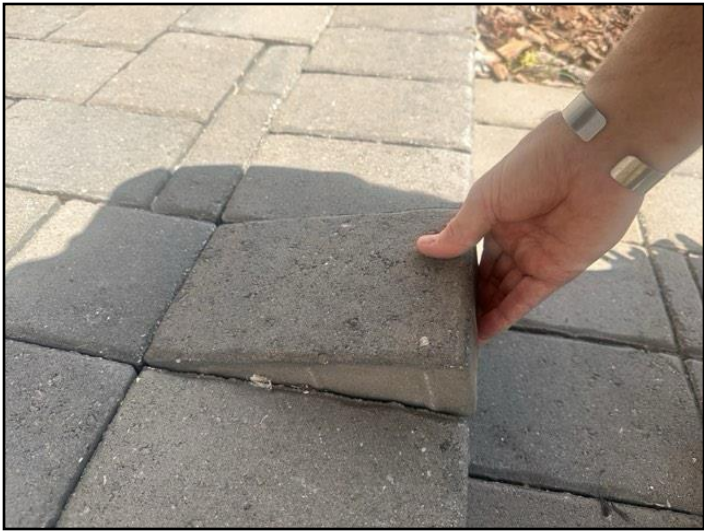
**7. Condition:** • Loose pavers create a trip hazard

Loose paver present at front entrance.

**Task:** Repair,

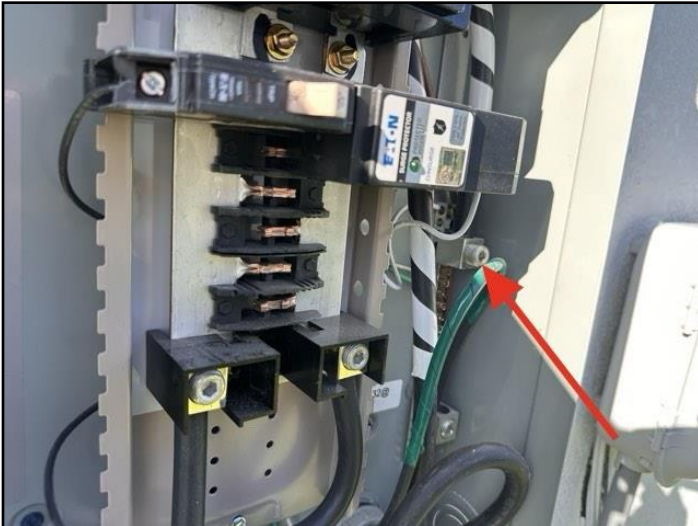
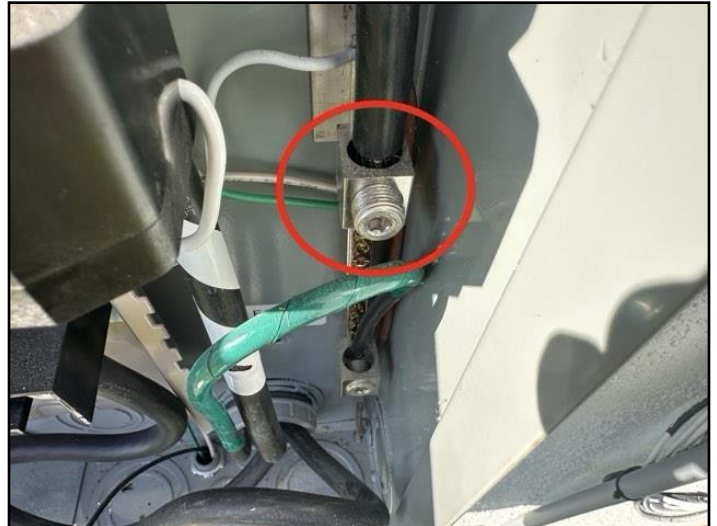
#### **9. Condition:** • Service conductor appears loose at main lugs.

**Task:** Electrician should verify torque

**Time:** Immediate,

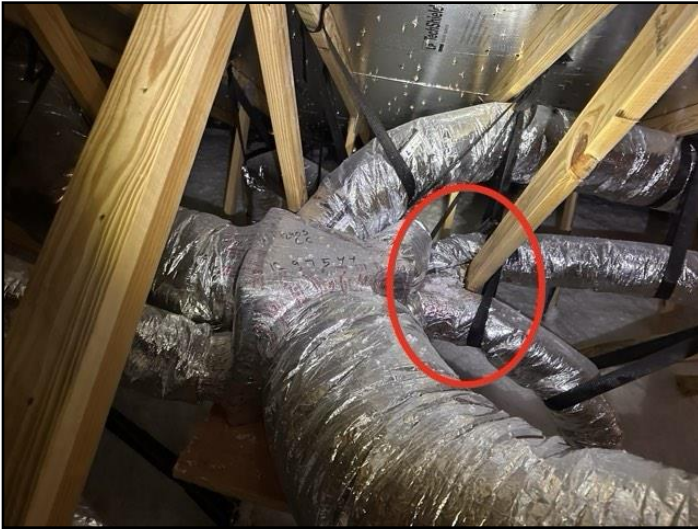
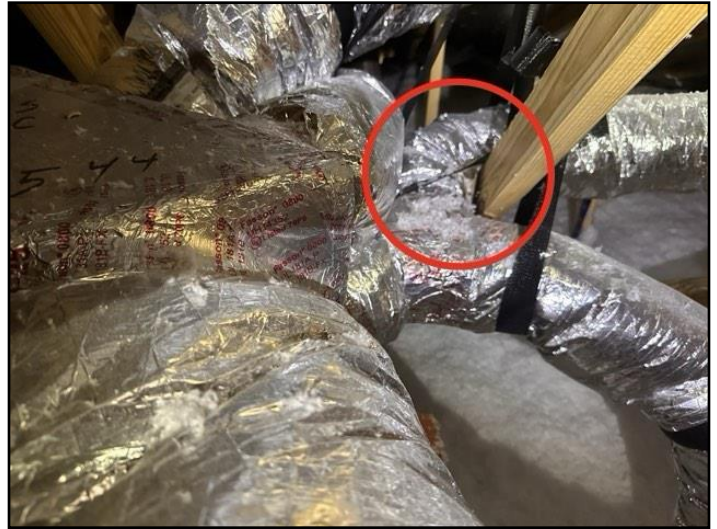
**12. Condition:** • Owner concerned that the Master bedroom and right front bedroom are always warmer than the rest of the home.

both 6", 8" & 10" which is typical. However, there is a 6" duct connected to the side of another 6" duct after the plenum. This method may be the cause of the uncomfortable issue but must be determined by a qualified technician to balance the HVAC & duct system.

Recommend each vent be tested to ensure the correct amount of air volume is being supplied to each room. Jumper ducts do not appear to be installed or are not installed to connect all outer rooms.

**Task:** Further evaluation by qualified professional,

**Time:** Immediate,

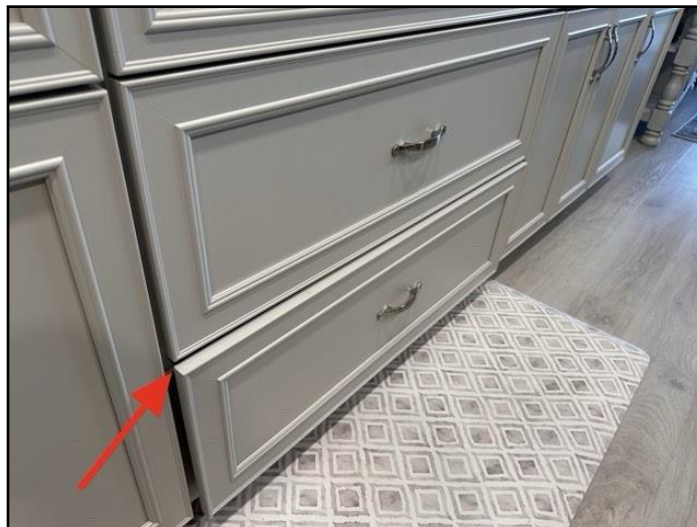
**13. Condition:** • Stiff or Inoperable drawers

**Task:** Repair,

**Time:** As soon as possible,

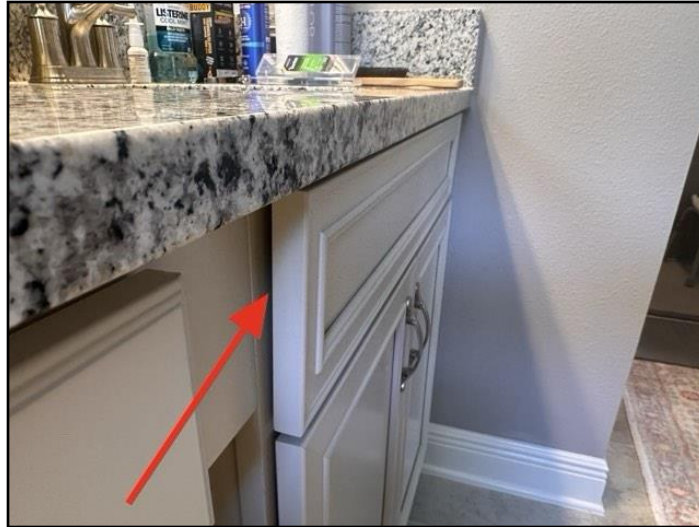
**14. Condition:** • [Loose or missing pieces](#)

**Task:** Repair or replace,

**Time:** As soon as possible,
