# Inspection Report

#### West Bayshore Court #1/2  
Tampa, FL 33611

RE: Report No. 1651

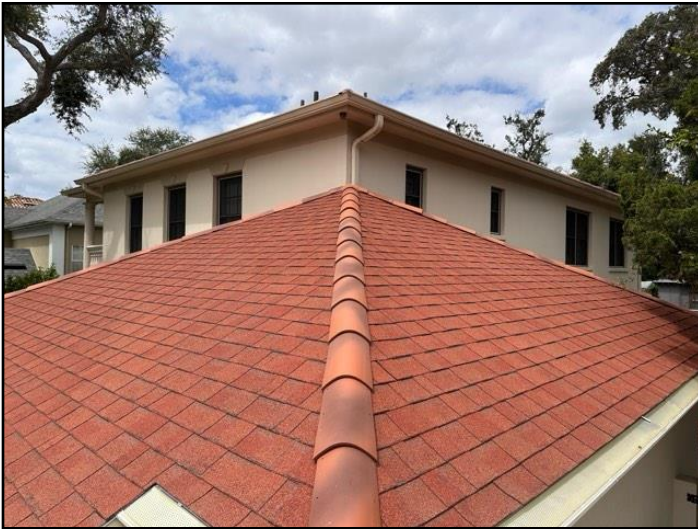
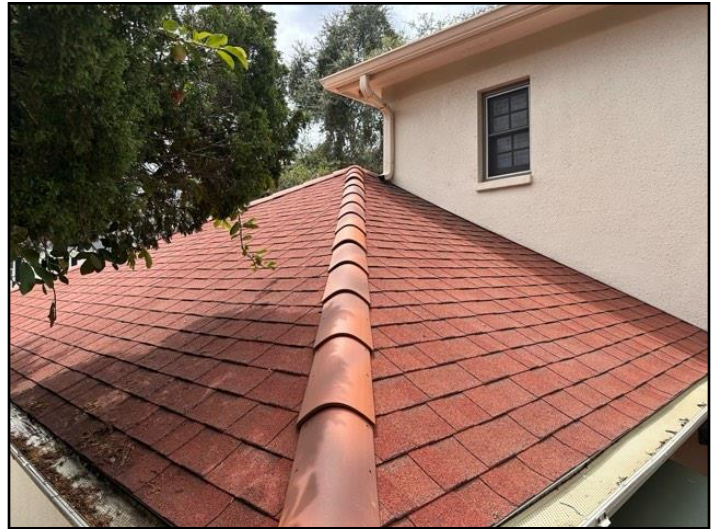
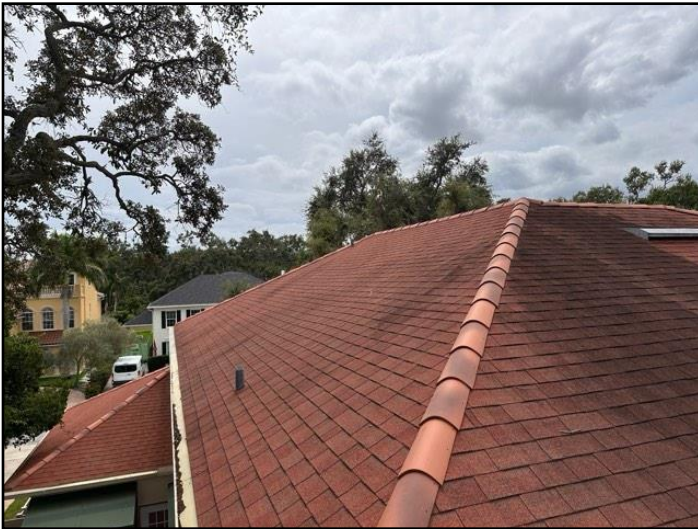
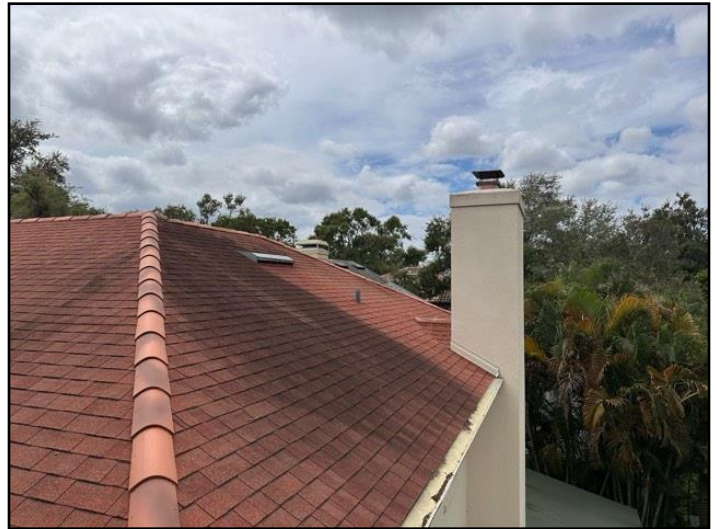
**Sloped roofing material:** • Composition shingles

**Flat roofing material:** • [Modified bitumen membrane](#)

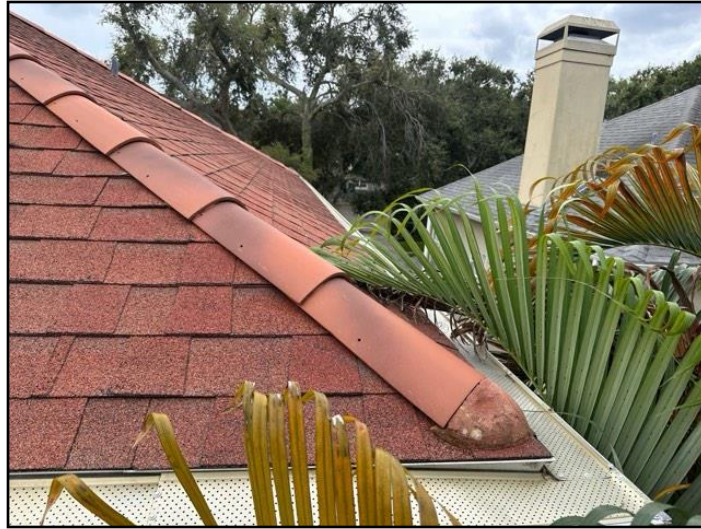
**3. Condition:** • Debris / Limbs/ Leaves / Moss on roof will cause premature failure

Clean roof of debris. Excessive debris, primarily leaves will hold moisture and speed the deterioration of all roofing materials and/or lead to leaks. Trees should be trimmed appropriately and debris on roof should be removed regularly to prolong roof life. If your roof is shingled, do not sweep leaves as this will remove granules from shingles and speed deterioration.

**Implication(s):** Water damage, rapid deterioration of sheathing and roofing materials

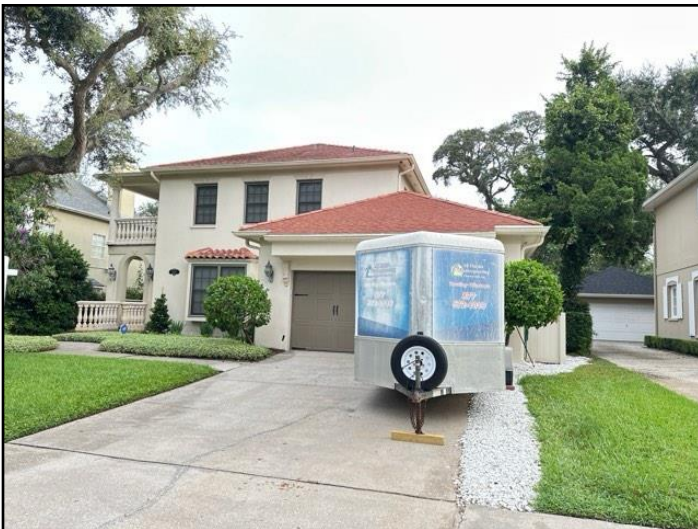
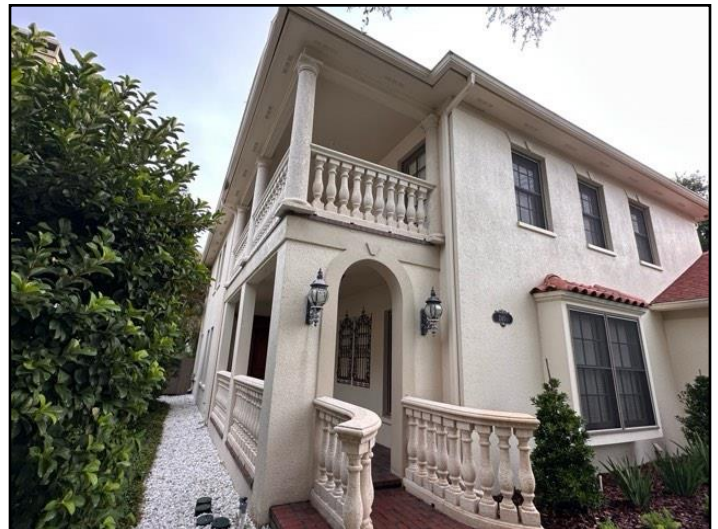
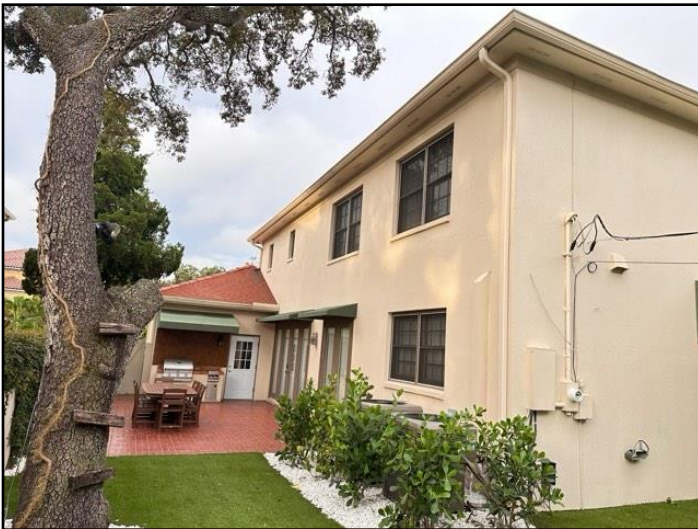
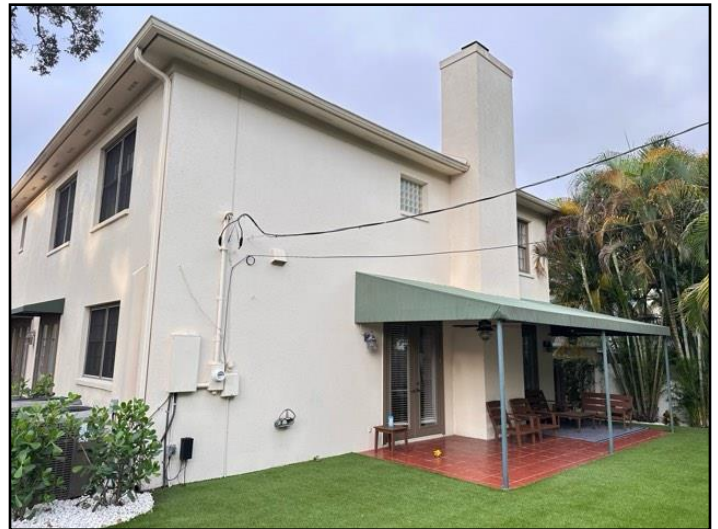
- General View of Exterior

**Wall surfaces and trim:** • Stucco on block

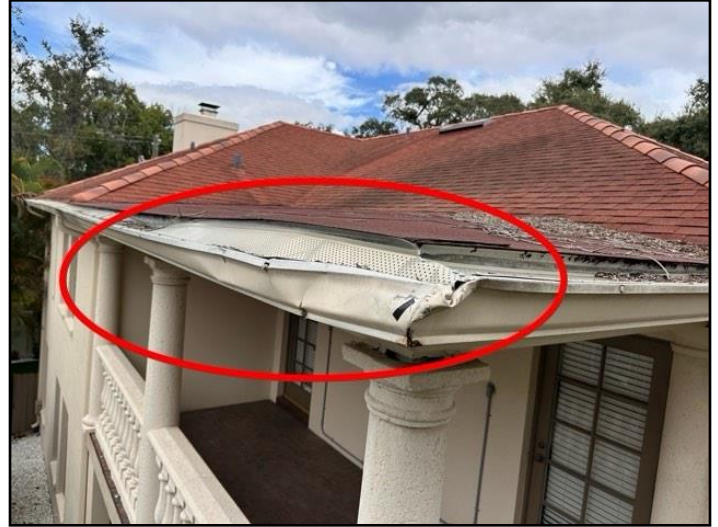
**4. Condition:** • Gutter or Downspout loose or damaged in one or more locations  
Gutter, damaged and leaking at one or more locations around the home.

**Task:** Repair or replace,

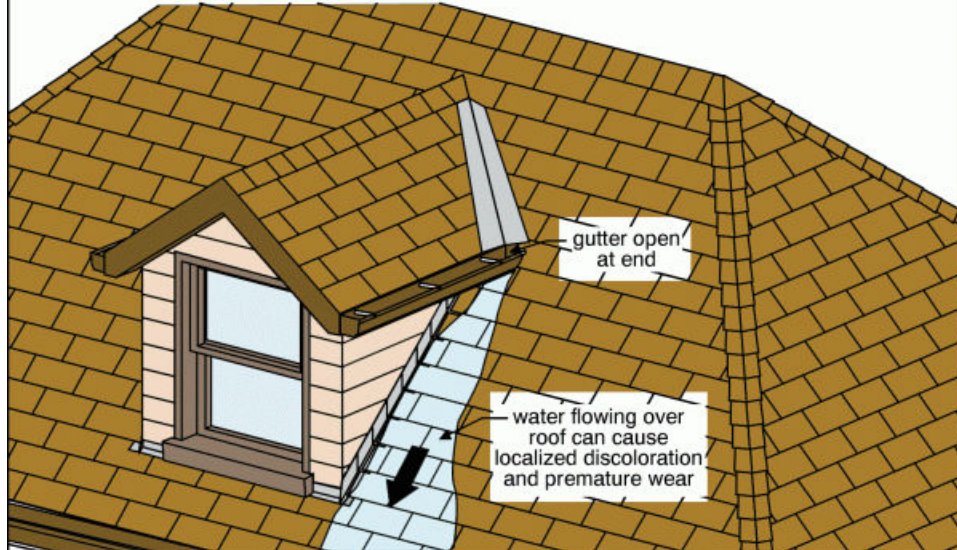
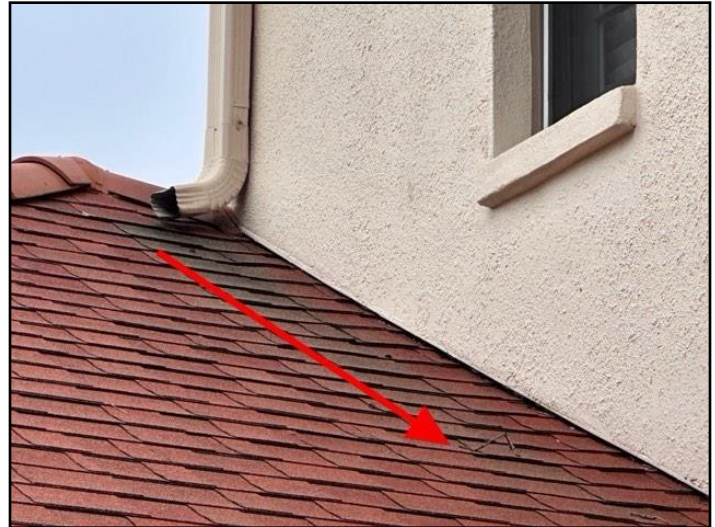
## No downspout on secondary roof

**5. Condition:** • Gutter discharges onto roof in one or more locations

Gutters discharging onto a lower roof will speed the wear of roof material. Recommend installing downspouts to direct water directly into lower gutters to protect the structure and prevent premature failure of roof materials.

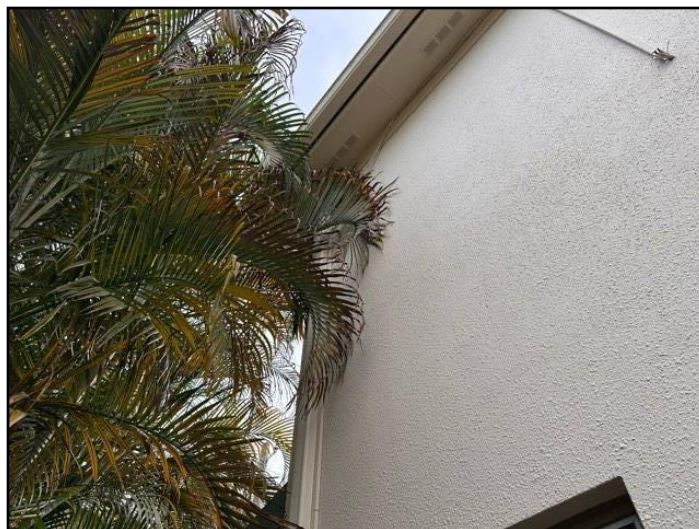
**10. Condition:** • Tree limbs touching house- Trim trees

**Task:** Trim trees/ Regular maintenance

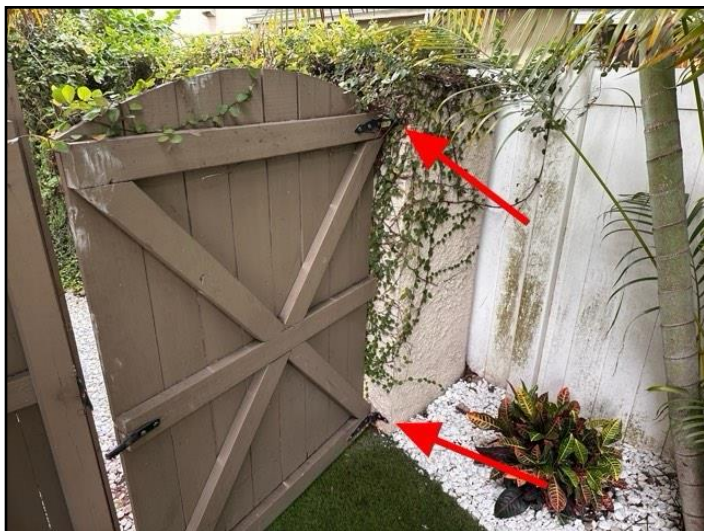
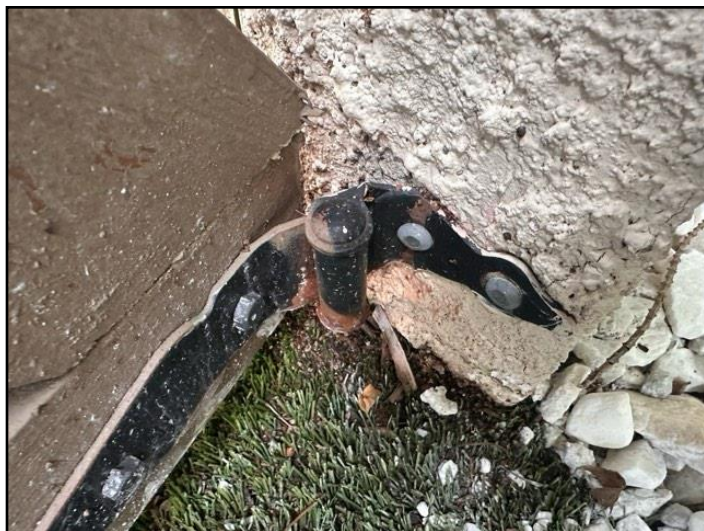
Gate hinges are severely corroded and and off. This is bending the frame of the hinge. Replaced as needed.

**11. Condition:** • Gate damaged

**Task:** Repair or replace,

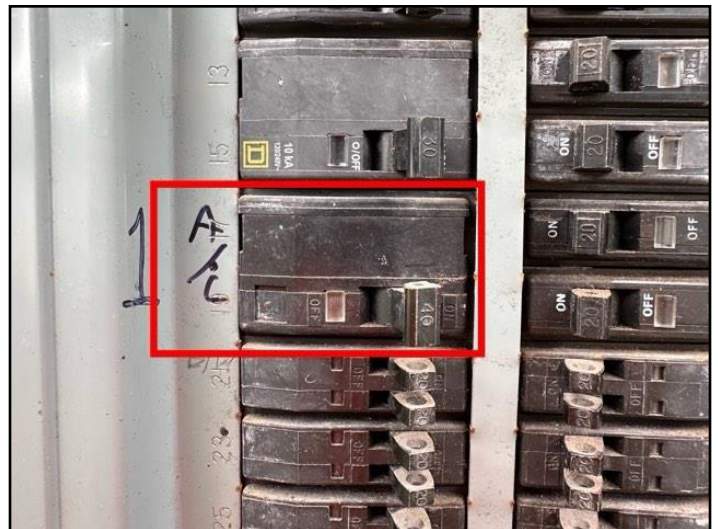
Breakers are sized for the equipment, system or circuit they supply as required by the manufacturer. Oversizing breakers can cause damage to the equipment, electric shock or fire due to not tripping (stopping power to the circuit) when a fault occurs. Recommend evaluation & correction as required by a licensed professional electrician to verify all equipment breakers are properly sized.

**15. Condition:** • Breaker Oversized for equipment/system

**Task:** Repair, 4-POINT FAILURE

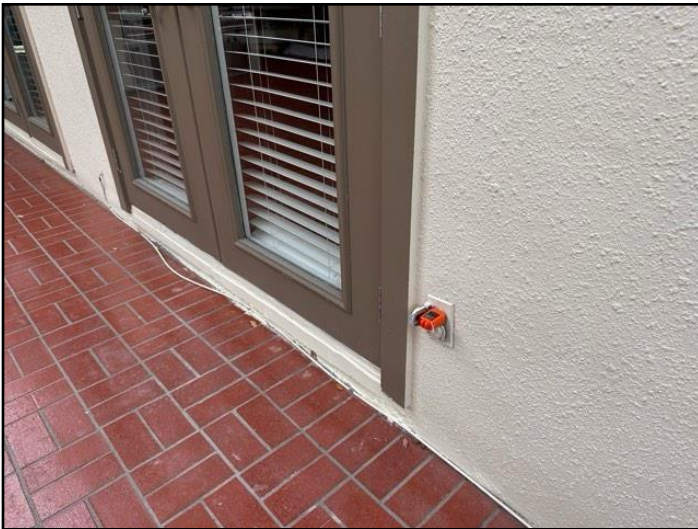
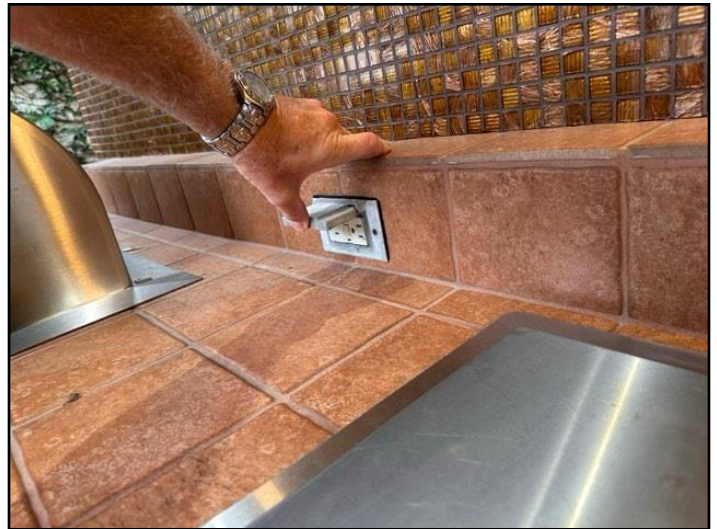
**18. Condition:** • [Inoperative](#)

One or more receptacle and/or light switch was inop during the inspection. No switches or GFCIs were found to operate these receptacles as a switched/protected receptacle.

**Task:** Repair, 4-POINT FAILURE

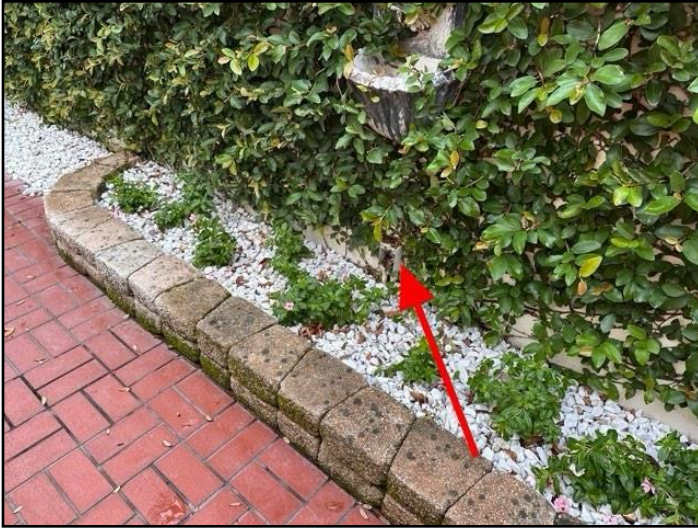
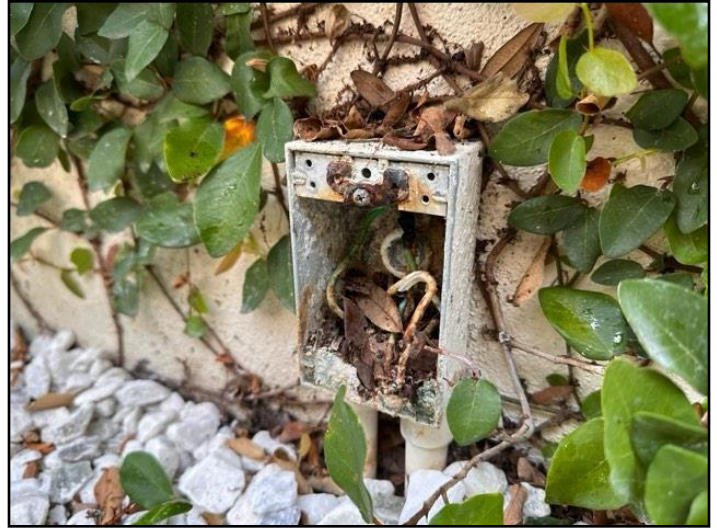
**19. Condition:** • Coverplate missing, loose or damaged- Required

**Task:** Repair, 4-POINT FAILURE

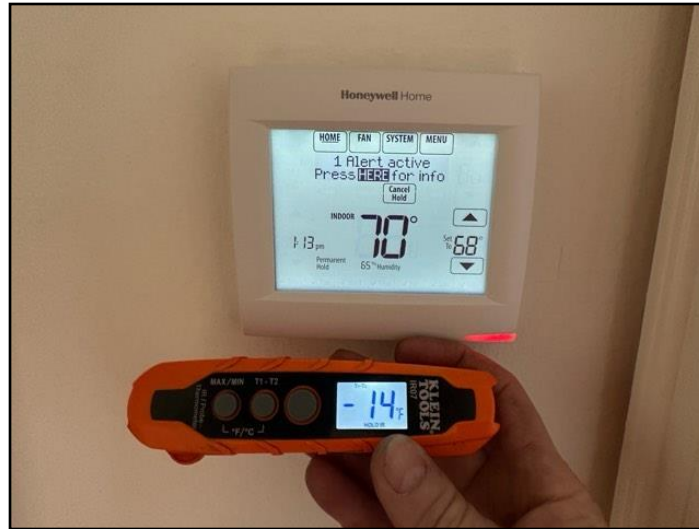
• 23°

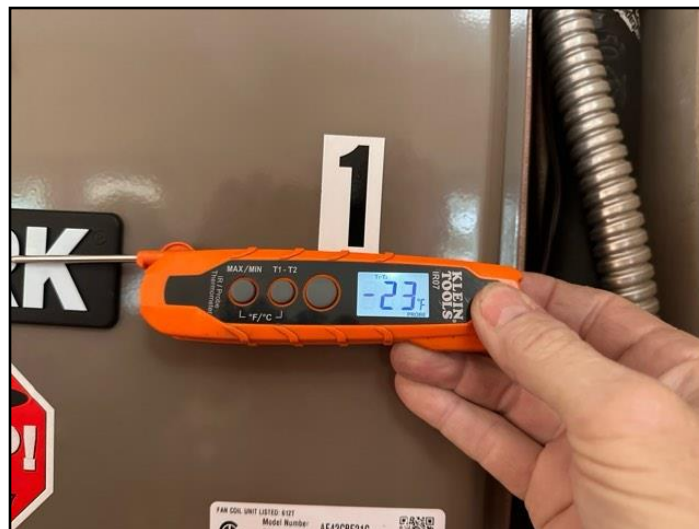
• This suggests good performance in cooling mode. Regular service and monthly filter replacement is recommended to ensure reliability and efficiency of the system.

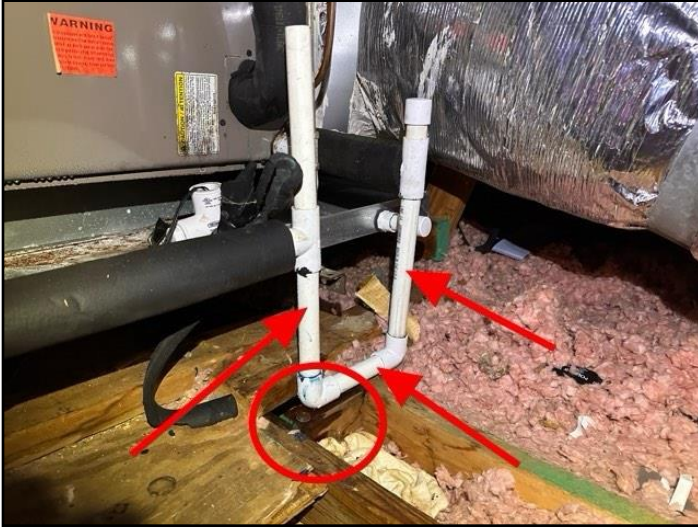
*Water damaged framing & ceiling*

**Task:** Repair, 4-POINT FAILURE

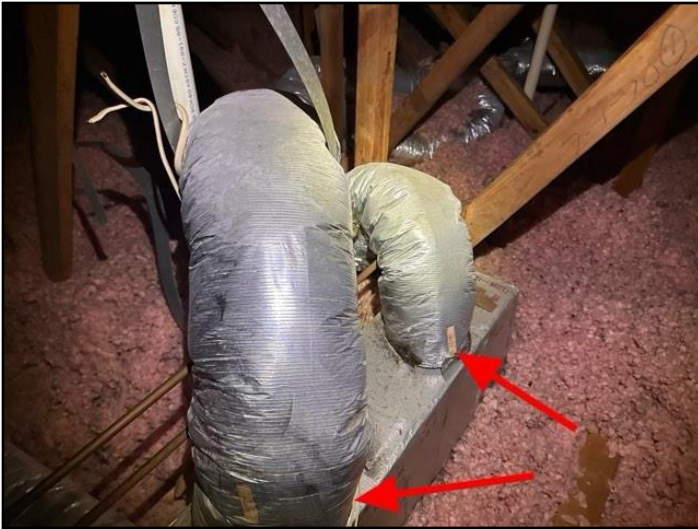
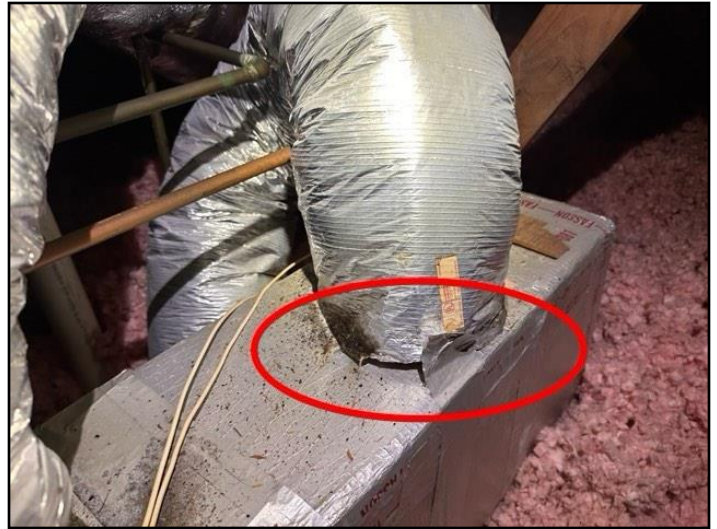
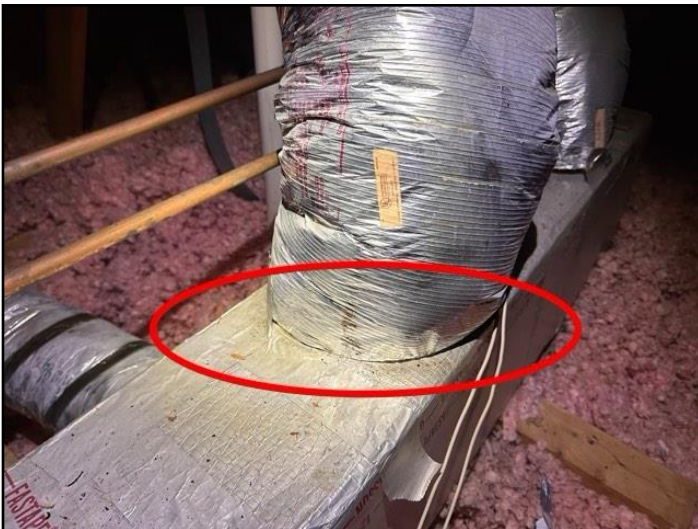
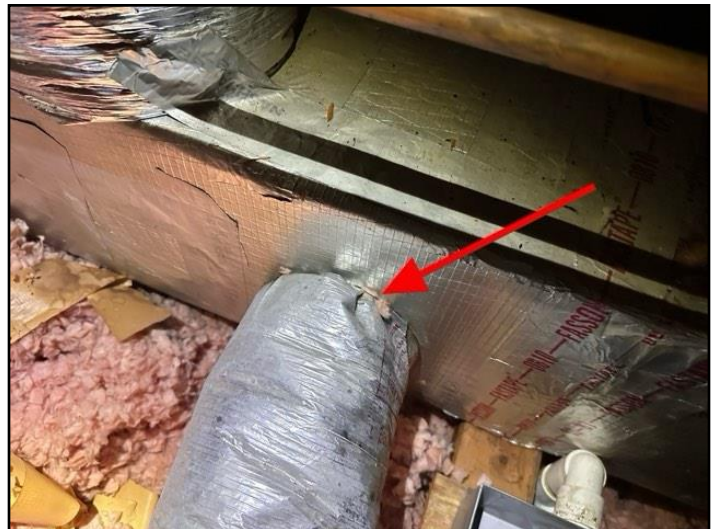
## 25. Condition: • Ducts poorly connected

Ducts are poorly connected at one or more locations. Duct connections should be sealed with a mastic paste to better seal and reduce leakage at joints.

**Task:** Repair,

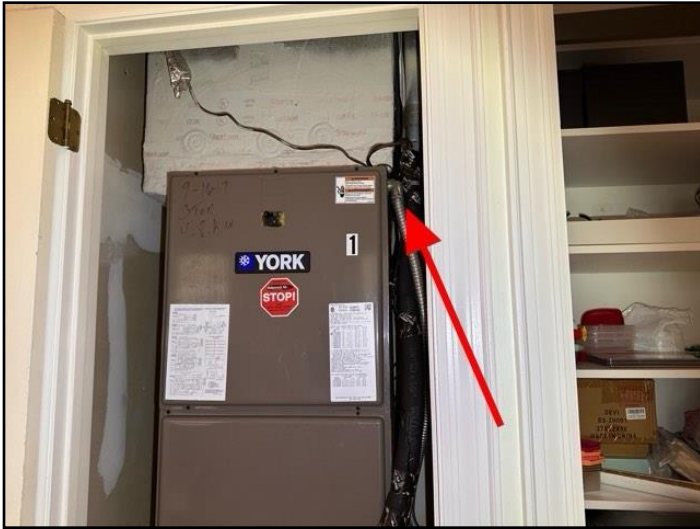
Air handler plenum leaking air and causing organic growth. These areas should be cut out and replaced and properly sealed.

**26. Condition:** • Air handler cabinet/ plenum is leaking air/ not fully sealed. Seal cabinet to ensure maximum efficiency of HVAC system.

**Task:** Repair,

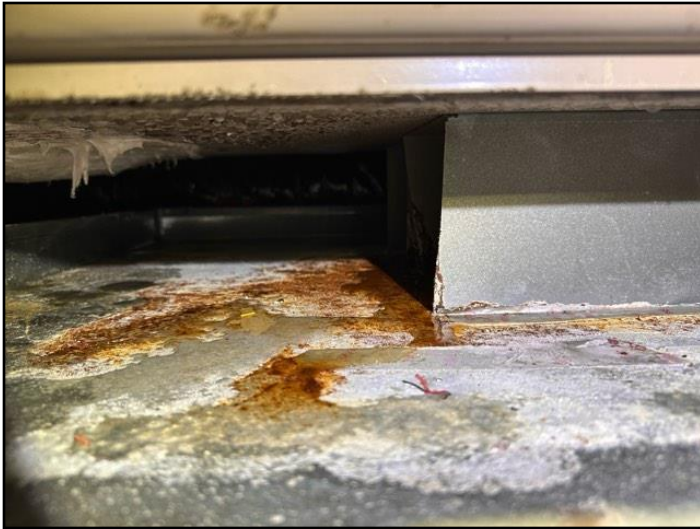
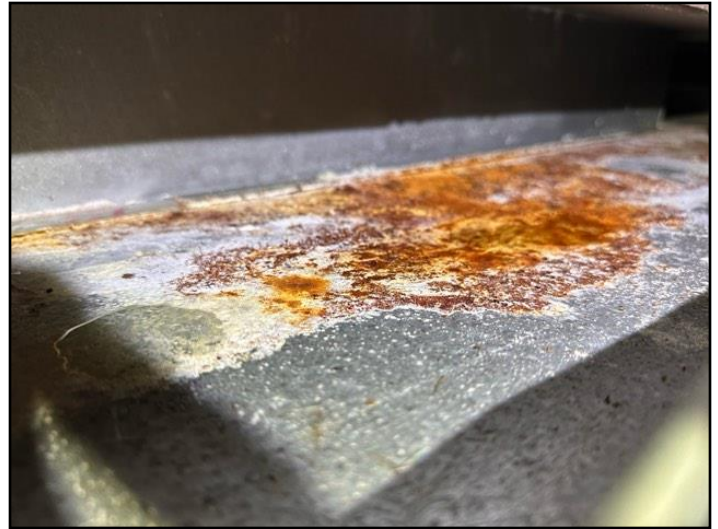
**27. Condition:** • Condensation/ Overflow drain pan has excessive corrosion or leaking

**Implication(s):** Chance of water damage to structure, finishes and contents

**Task:** Replace, 4-POINT FAILURE

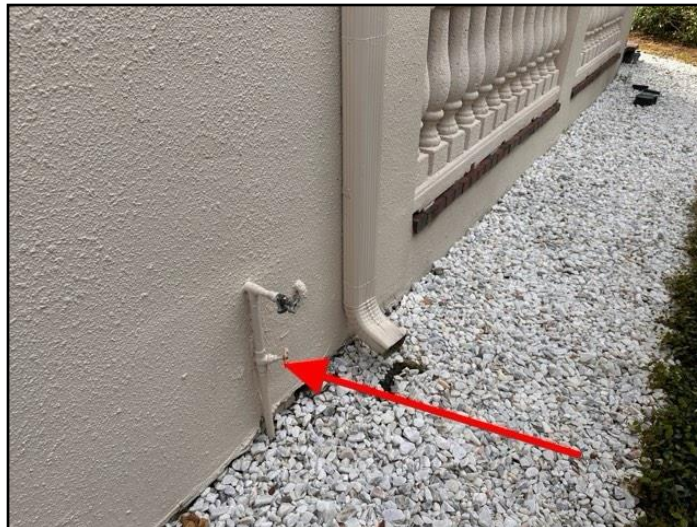
*Main water shutoff valve*

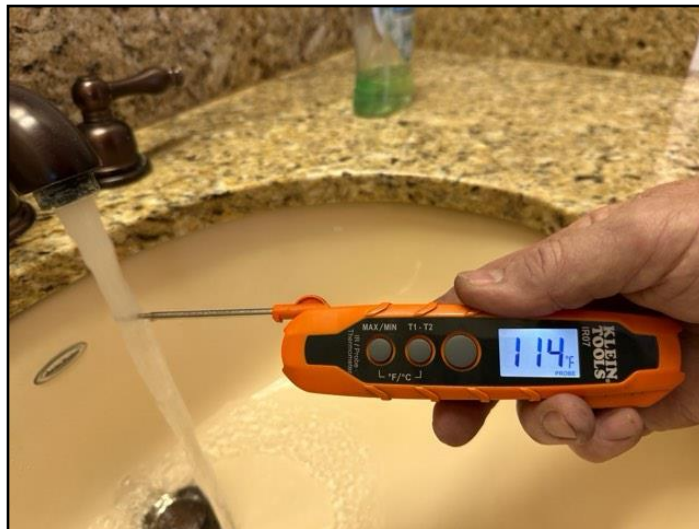
**28. Condition:** • Water temp low- Recommend 120 degrees

Recommended water heater temp is 120 degrees. If this is an older unit, lower temps may be an indication of an aging water heater in need of repair or replacement. If this is a newer unit, adjust water heater temp closer to 120 degrees without exceeding 130, as higher temps can scald. This can simply be done by following the manufacturer's instructions for adjustment and checking water temp in approximately 30 mins. If there are mixing valves present, as in newer homes, recommend adjusting any mixing valves if temp is lower at one faucet than another after running for 2 minutes.

If the temperature does not rise accordingly, contact a licensed professional plumber for evaluation and replacement options.

**Task:** Adjust and replace if needed

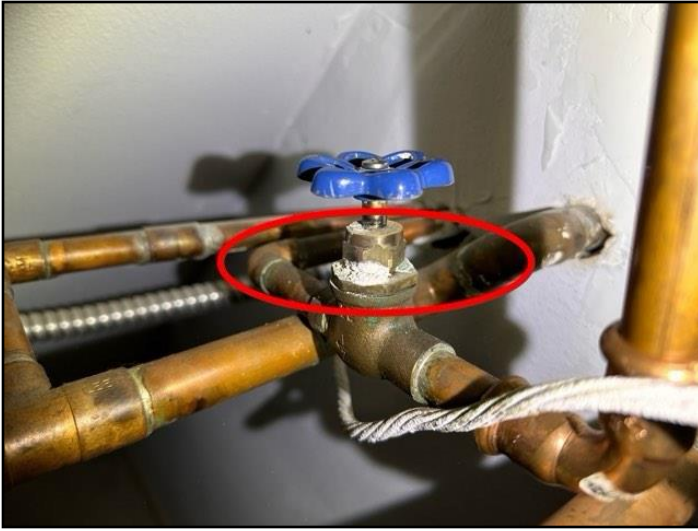
Gate valves are prone to leaking and should be replaced with a ball valve to protect the structure.

**29. Condition:** • Rust/ Corrosion on water heater or pipes

**Task:** Replace, 4-POINT FAILURE

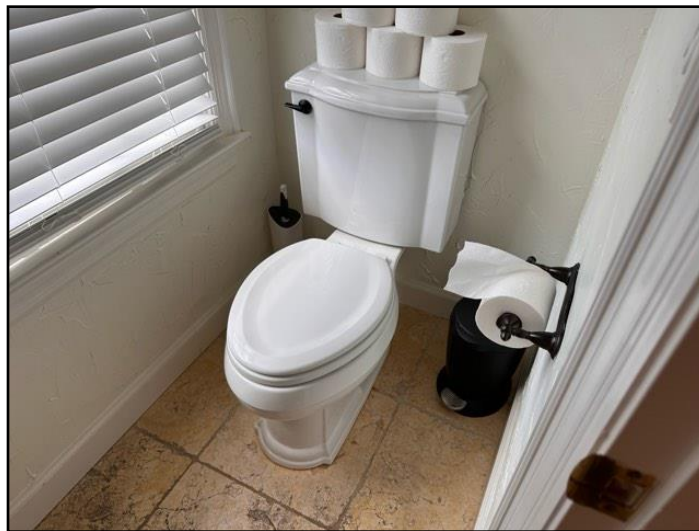
## Loose toilet

Loose toilets may hide damage that can only be seen when toilet is pulled for repair. All additional damage to the flooring or structure should be repaired as needed. Recommend the toilet be seated with grout or silicone around the base and leave a section at the rear open to allow any leaks to present earlier and prevent future structure damage.

### **30. Condition:** • Loose toilet

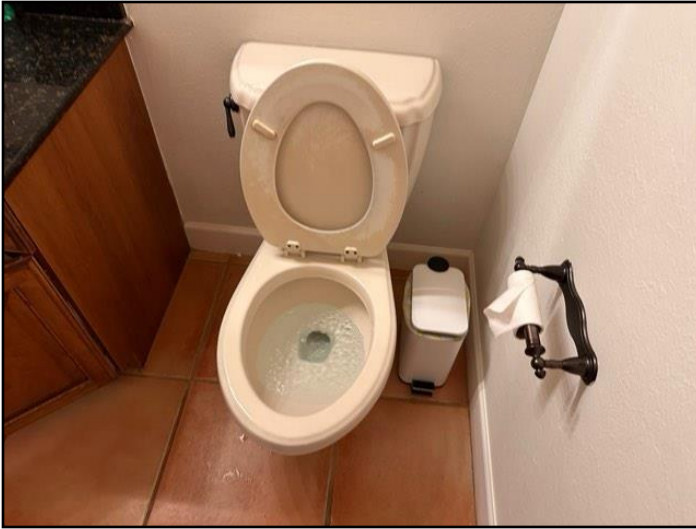
**31. Condition:** • [Broken or cracked tank lids, bowls or seats](#)

**Implication(s):** Chance of water damage to structure, finishes and contents | Physical injury

**Task:** Replace,

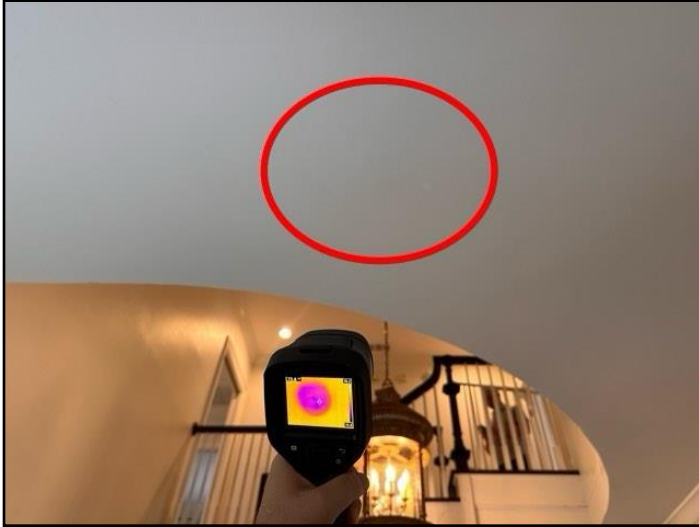
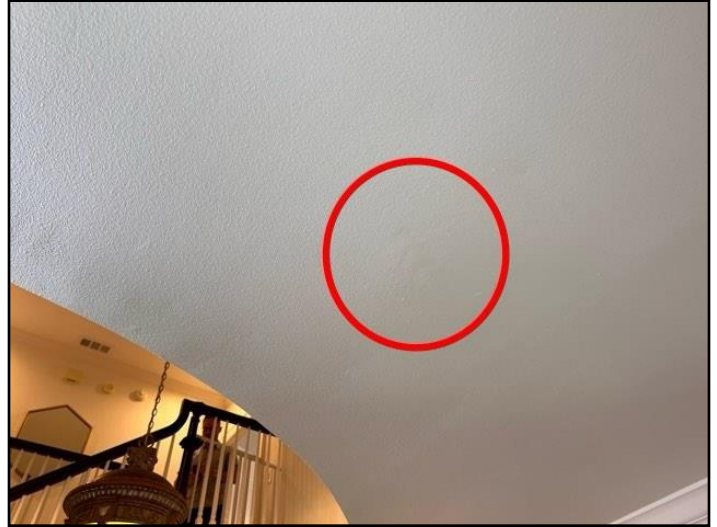
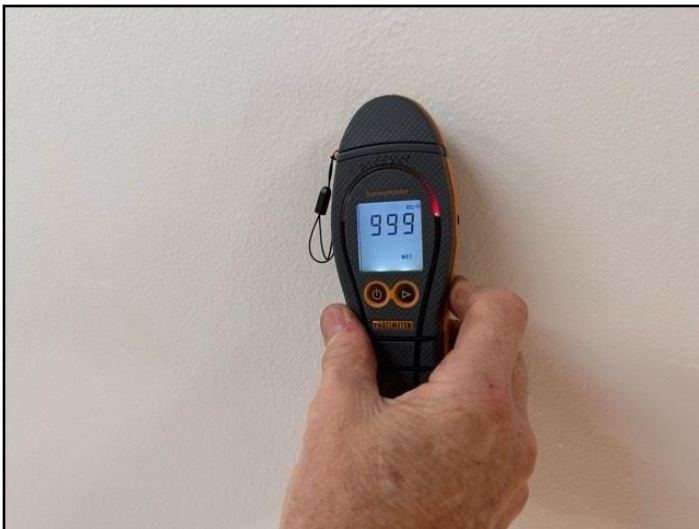
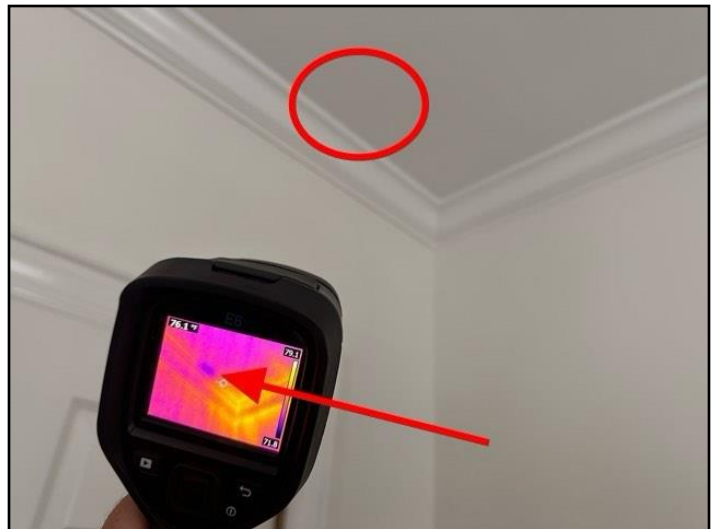
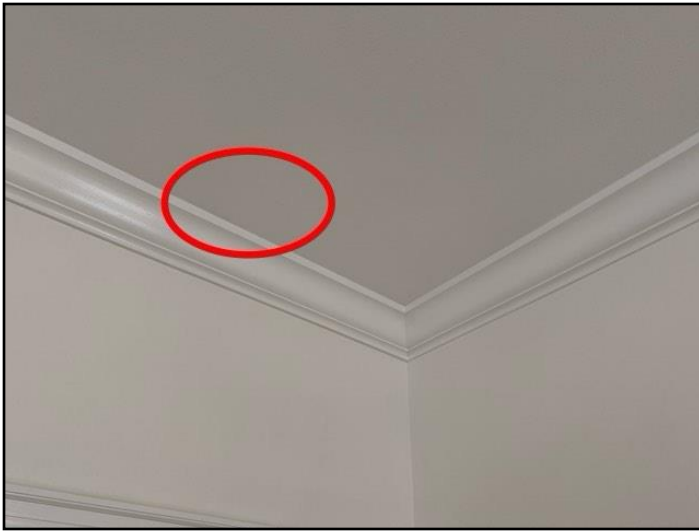
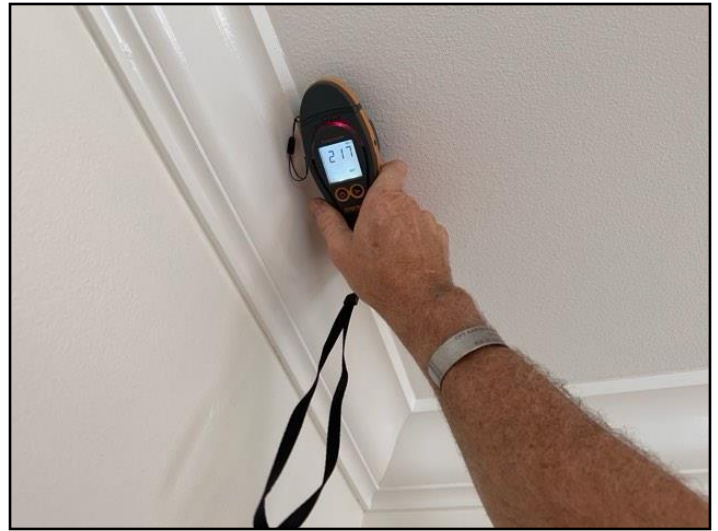
#### **33. Condition:** • Water stains with high moisture detected

The damaged area beneath the shower must be opened to repair.

**Implication(s):** Chance of water damage to structure, finishes and contents

**Task:** Further evaluation 4-POINT FAILURE

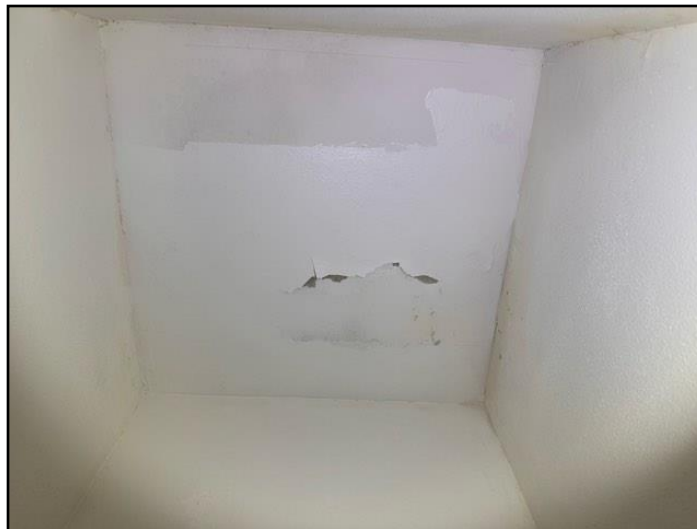
**34. Condition:** • Paint peeling/failing

Paint failing in closet. Possibly due to a previous leak at the air handler in the closet. Dry during inspection. Paint to seal.

*Paint peeling inside closet 2nd floor hallway*

**Task:** Repair,

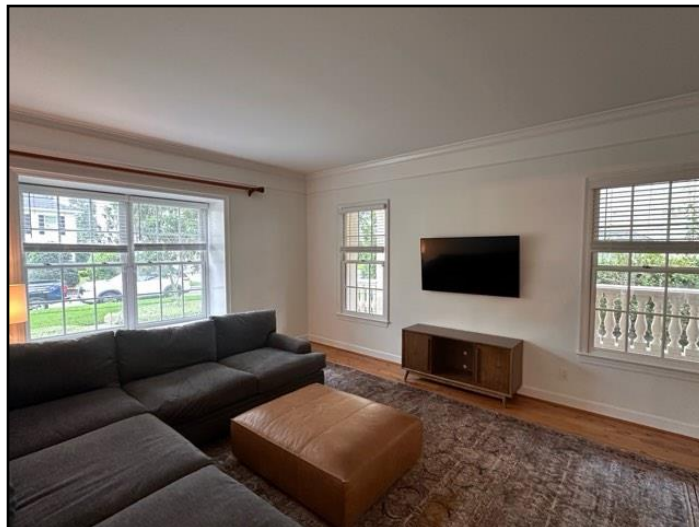
**36. Condition:** • Window painted/ caulked/ sealed shut and will not open. Correct fault to ensure window is accessible in emergencies.

**Task:** Repair,

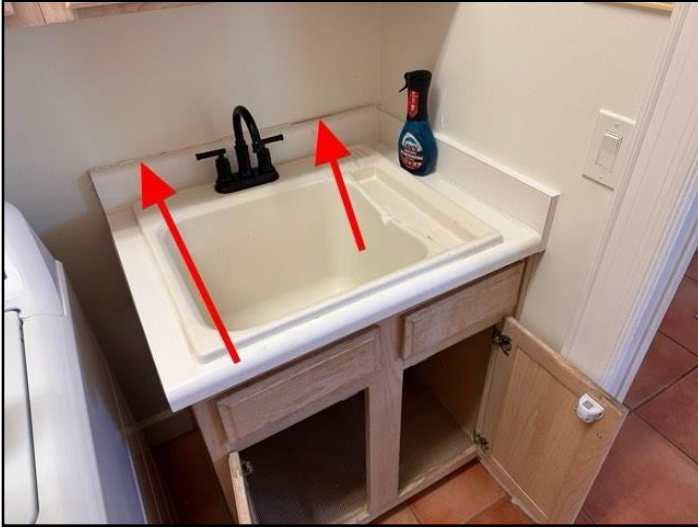
**38. Condition:** • Cabinet/vanity not properly mounted to prevent movement

**Implication(s):** Chance of water damage to structure, finishes and contents

**Task:** Repair or replace,  
**Time:** As soon as possible,

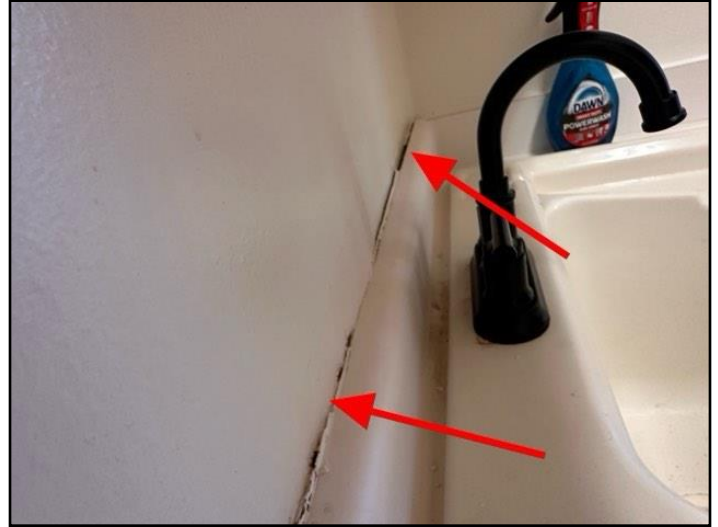
**39. Condition:** • Countertop caulking cracked/shrunk.

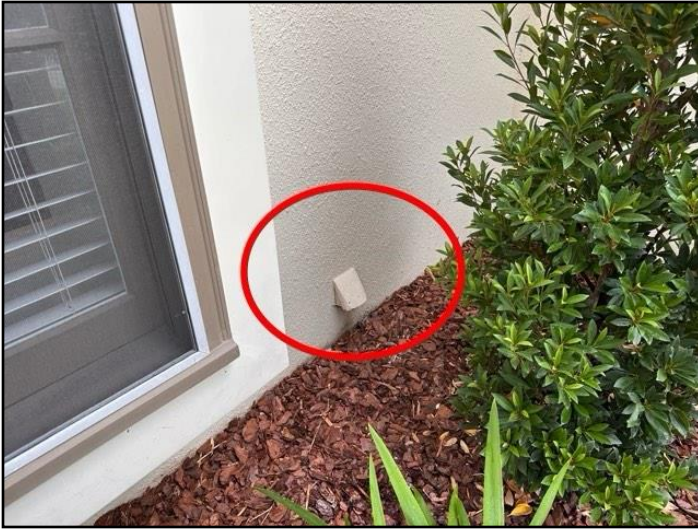
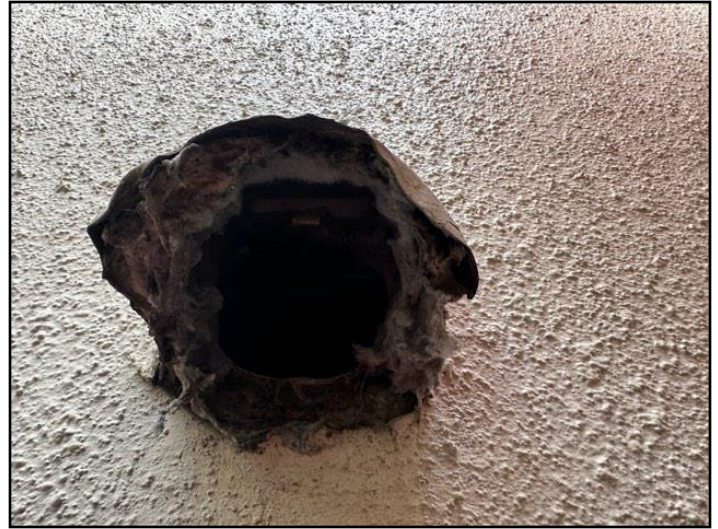
**40. Condition:** • Dryers and ducts require periodic cleaning to prevent potential fires

**Task:** Repair or replace,

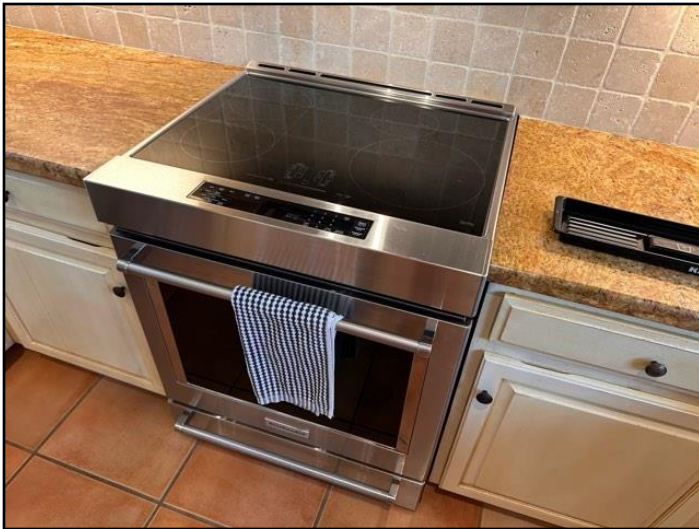
*Induction range not tested*
