Inspection Report

Pomander Avenue New Port Richey, FL 34653

Derle Parmer, HI11344

RE: Report No. 1579
Pomander Avenue
New Port Richey, FL
34653

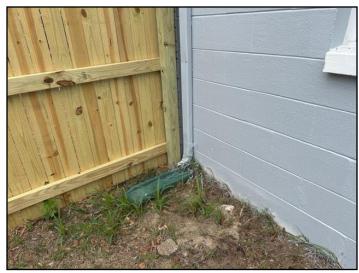
Condition: • Roof valley water discharge eroding soil and ponding next to foundation

Water discharged from an unprotected valley delivers countless of gallons of water in a single storm. Water should be moved 4-6ft away from the foundation but if allowed to discharge too close may cause ponding and future settlement issues. Recommend gutters if not installed. Gutters at valley corners require a splash shield to prevent water from shooting over gutter. Soil should also be sloped away from the foundation.

Location: Throughout

Task: Extend
Time: Immediate,

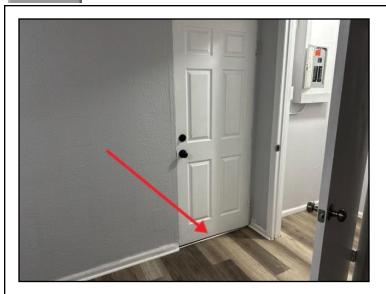
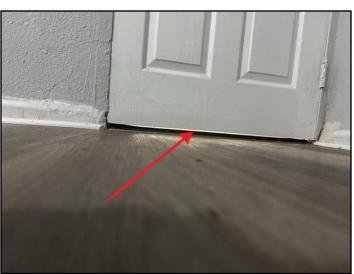
9. Condition: • Incorrect exterior door: not rated for exterior use.

Location: Left Side Task: Replace, Time: Immediate,

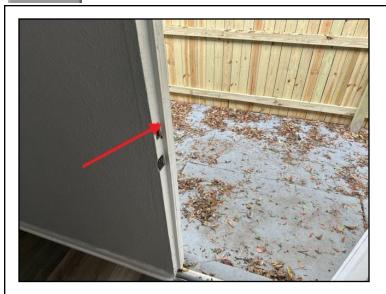
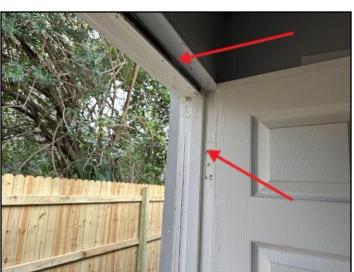
11. Condition: • Water damage on door or door frame.

Location: Left Side Task: Repair, Time: Immediate.

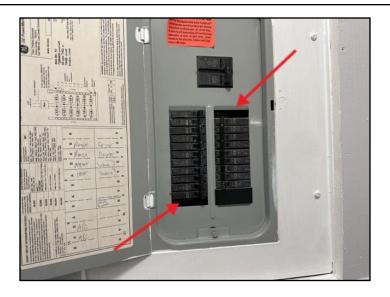
Breakers are sized for the equipment, system or circuit they supply as recommended by the manufacturer. Undersized breakers can cause damage to the equipment, electric shock or fire due to repeated tripping (stopping power to the circuit). Recommend correction by a licensed professional electrician.

This breaker powers the water heater which requires a minimum of 30 amps, which if replaced, the wire will require replacement to match the breaker size.

15. Condition: • Breaker undersized for equipment.

Task: Repair, Time: Immediate,

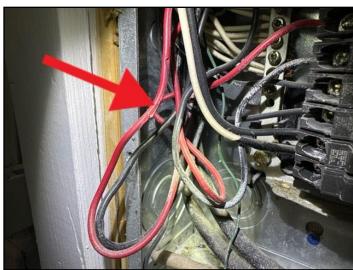
17. Condition: • Wire clamp not connected/ nut not installed on clamp

Task: Repair, 4-POINT FAILURE

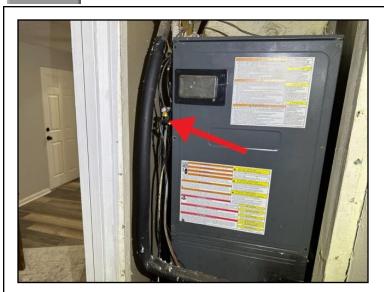
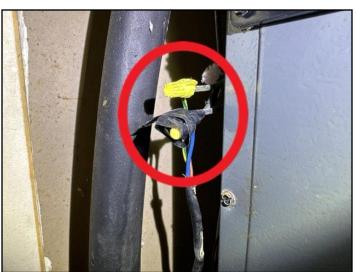
19. Condition: • Wiring not protected from physical damage- poor installation method Light incorrectly installed and does not prevent damage to wire around metal light base.

Location: Water heater closet light Task: Correct, 4-POINT FAILURE

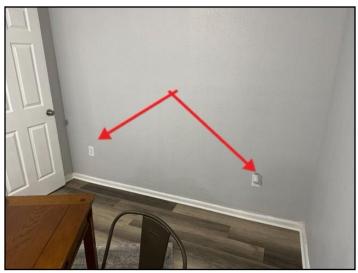
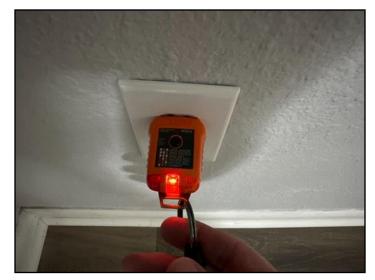
22. Condition: • Broken pin or blade in slots

Task: Replace, 4-POINT FAILURE

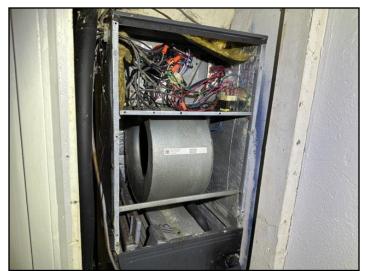
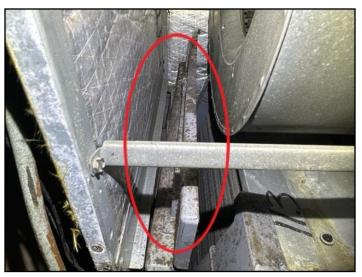
Condition: • Air handler has biological / organic growth inside cabinet

A biological/organic growth was discovered inside the HVAC system. This is common for this climate area but we do not test for biological substances as part of an inspection unless specifically requested. Recommend a thorough cleaning of all air handler components and ducts before occupying residence.

Task: Clean by HVAC Technician

Time: Immediate

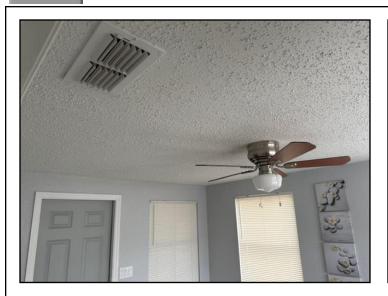
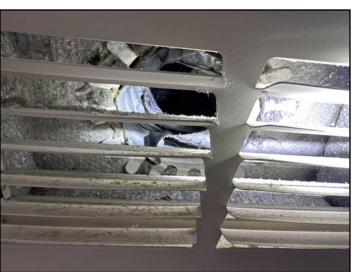
28. Condition: • Vent damaged or painted closed- will not open

Location: Kitchen **Task**: Repair or replace,

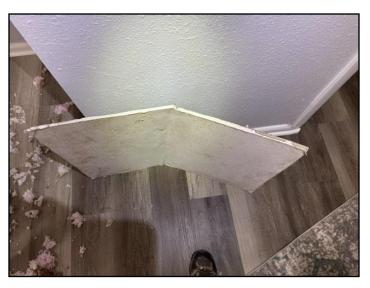
29. Condition: • Damaged

Attic door damaged- Replace with better material

Task: Repair or replace,

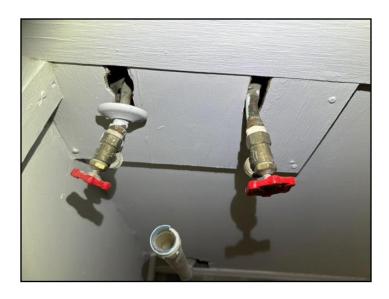
30. Condition: • Unsupported/ not professionally installed

Supply piping is required to be properly installed and supported to prevent movement resulting in damage to the structure.

Task: Repair, 4-POINT FAILURE

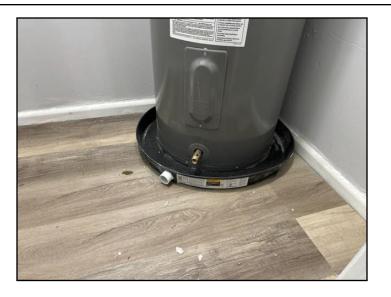
33. Condition: • Not properly connected at wall/drain

Task: Repair, 4-POINT FAILURE

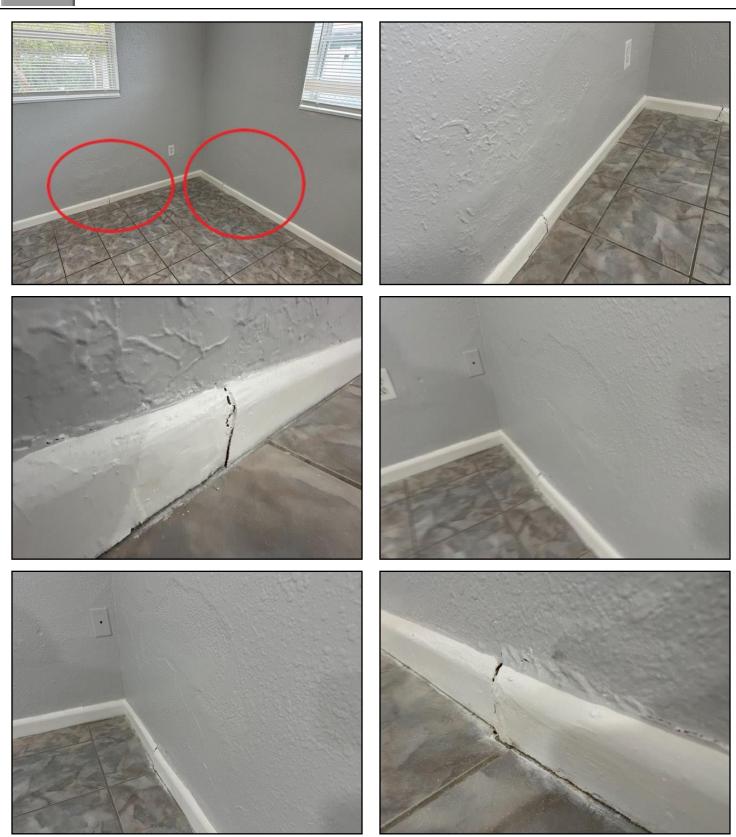
38. Condition: • Damaged

Walls and baseboard have signs of previous damage/repair. No active moisture found during inspection with thermal camera or moisture meter. Recommend replacement of all damaged material.

Additional water damage may be present that can only be seen when removing material for repair.

Task: Repair.

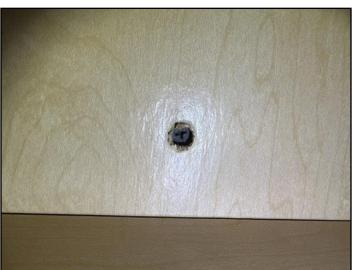
39. Condition: • Cabinet improperly installed

One or more cabinet(s) secured to wall without washers on the screws. Replace with proper screws or remove screws one at a time and add washers to prevent cabinet from falling when loaded.

Location: Kitchen Task: Repair, Time: Immediate,

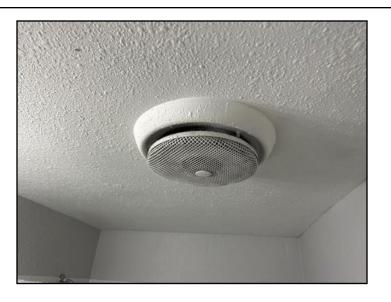
41. Condition: • Bathroom vent/ exhaust fan inop

Location: Hallway Bathroom **Task**: Repair or Replace,
