# Inspection Report

South Beverly Avenue  
Tampa, FL 33609

Tuesday, July 1, 2025

RE: Report No. 1630  
South Beverly Avenue  
Tampa, FL  
33609

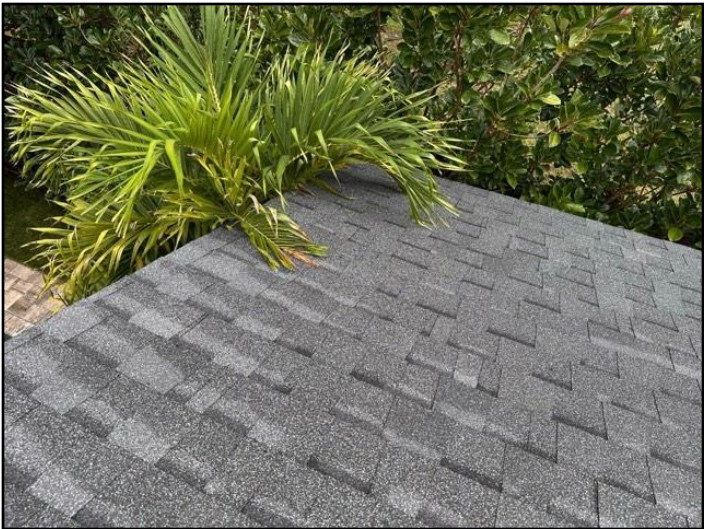
**Condition:** • Tree limbs touching roof

Tree limbs touching roof will speed the deterioration or damage roofing material and structure. All limbs that touch or have the potential to touch the roof material or home should be trimmed regularly.

**Implication(s):** Damage to roof and structure

**Location:** Right Rear  
**Task:** Trim trees,  
**Time:** Immediate,

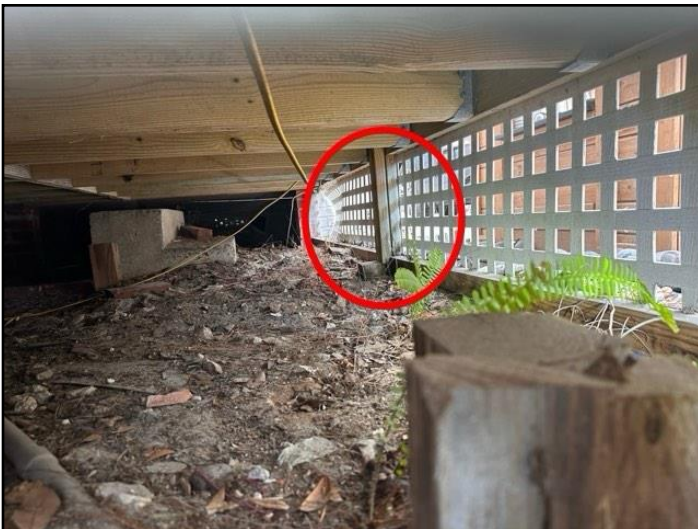
Multiple visible issues require further evaluation by a qualified foundation professional. Multiple areas where improper supports are placed to carry the load above. Additionally, wood supports in direct contact with soil and rot is present.

*Rotten supports*

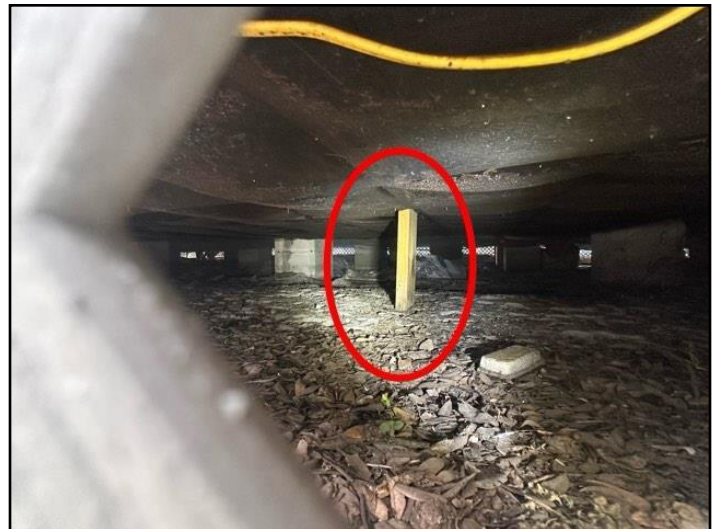
Wood framed wall in contact with soil will allow moisture and insect damage over time. Water damage present in one or more locations. Remove soil at least 4-6 inches to protect structure.

*Multiple perimeter supports are wood in soil*

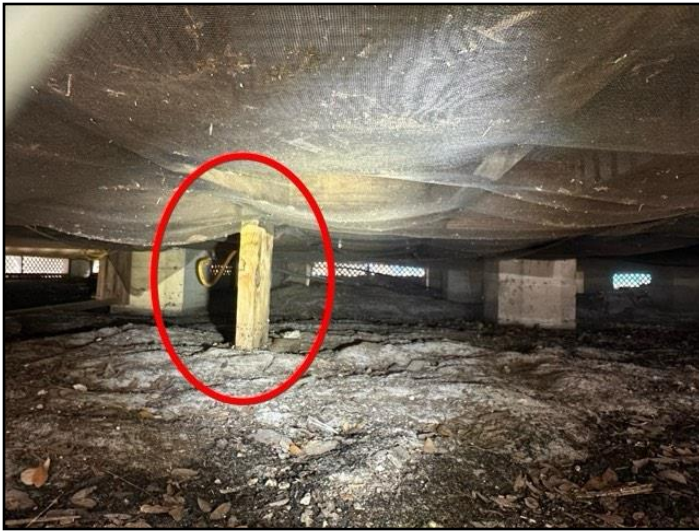
*Multiple single board supports present*

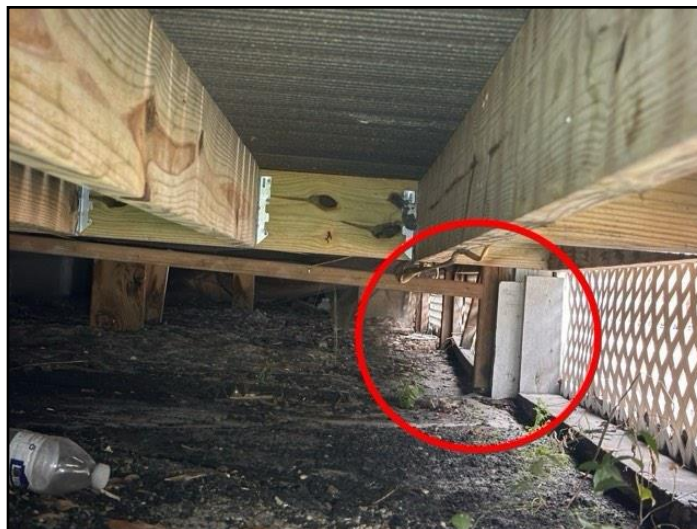
*Multiple perimeter supports are wood in soil*

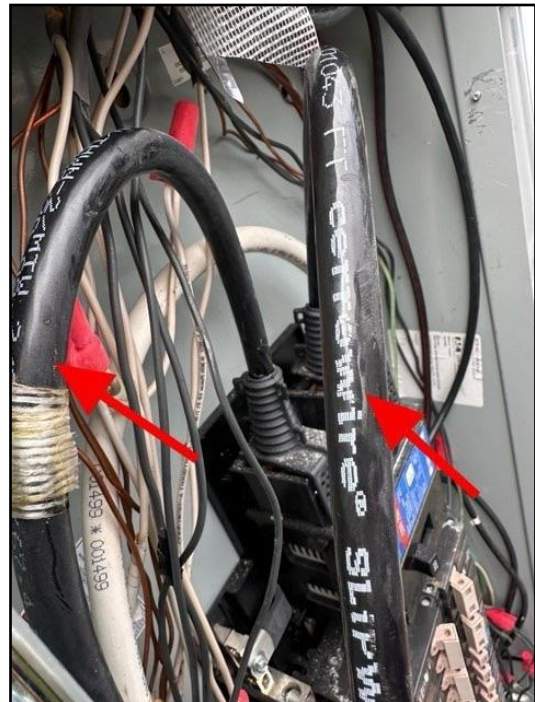
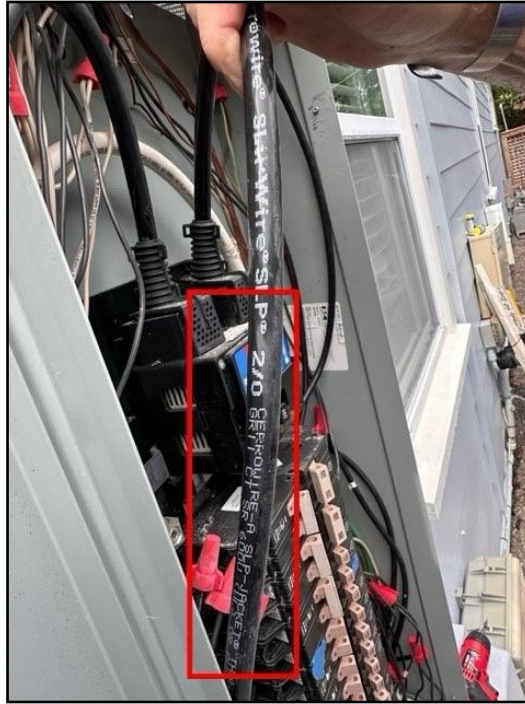
**Condition:** • Inadequate service size for this home. Recommend further evaluation by a licensed professional electrician to determine proper size wire based on a complete load calculation.

*Service wire possibly undersized*

Recommend evaluation and correction as needed by a qualified professional electrician.

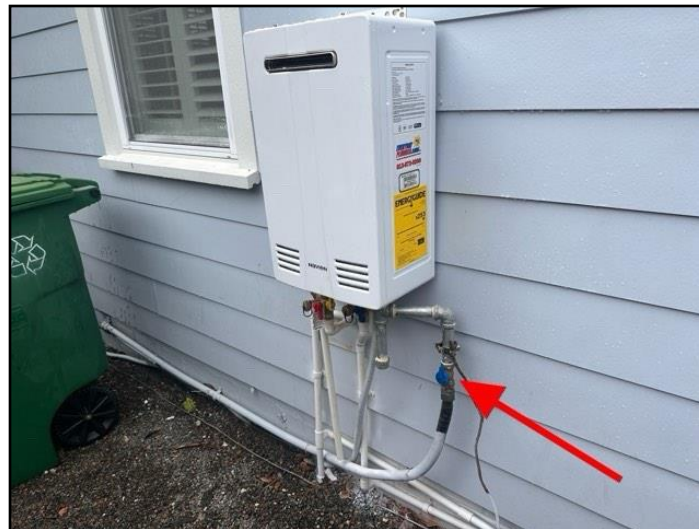
Water heater gas shutoff valve

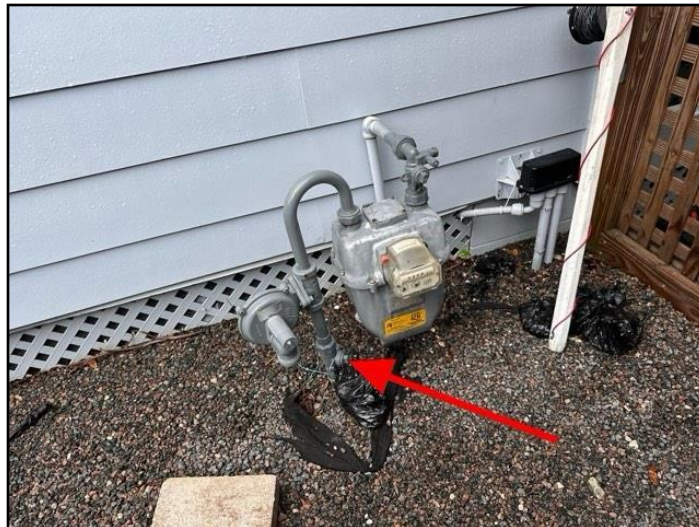
*Main gas shutoff valve*

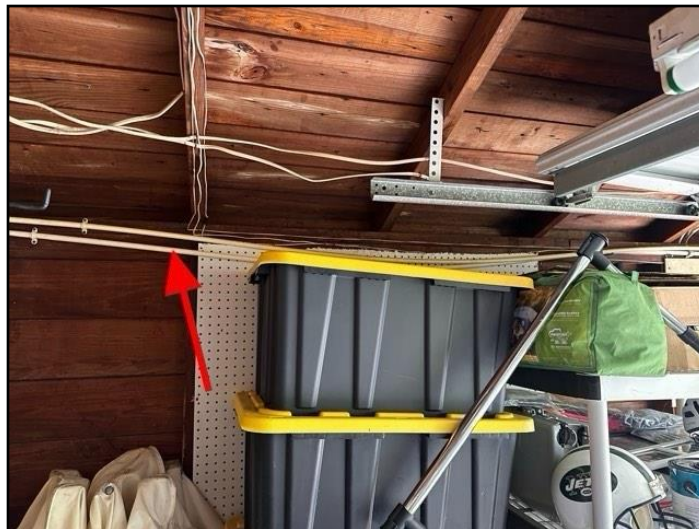
**34. Condition:** • Water pipes not insulated to protect from cold temperatures

All water pipes exposed to the exterior and hot water piping located outside the conditioned space are required to be insulated to a minimum value of R3.

One or more pipes on the exterior or in the attic require insulation to protect from freezing and possible water damage to the structure.

**Task:** Repair, 4-POINT FAILURE

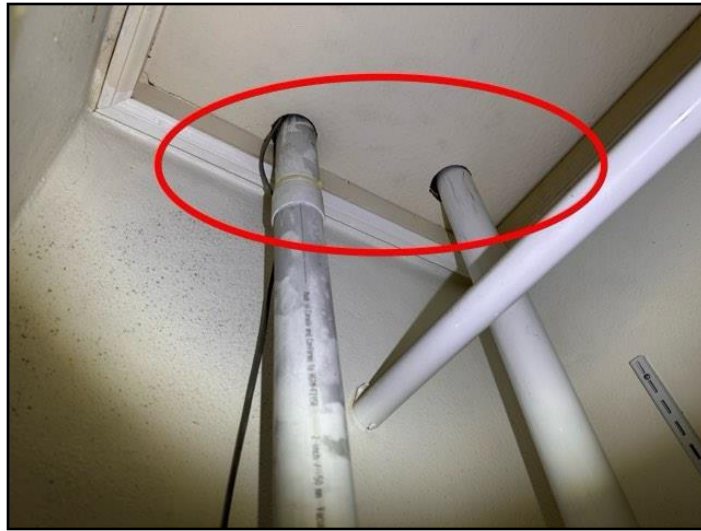
#### **38. Condition:** • Ceiling not sealed from attic- hole/opening present

Ceilings should be completely sealed to prevent hot and humid attic air from being pulled into the living space. This may cause mold growth if conditions are ideal.

**Task:** Repair,

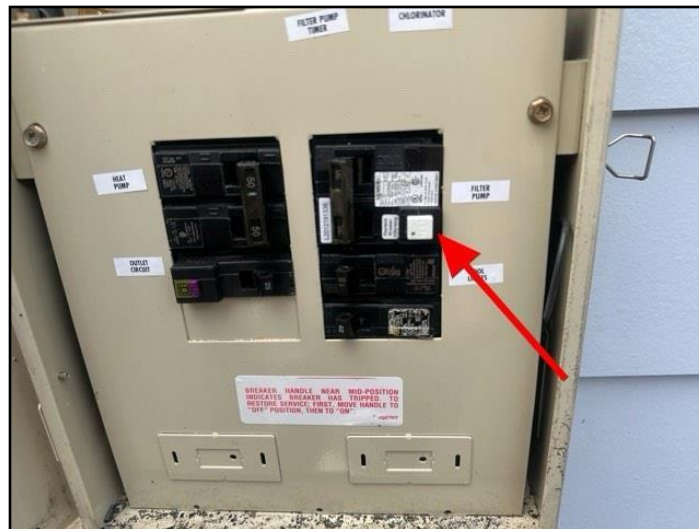
**43. Condition:** • Pool GFCI breaker faulty/ will not trip when tested

**Task:** Replace, 4-POINT FAILURE

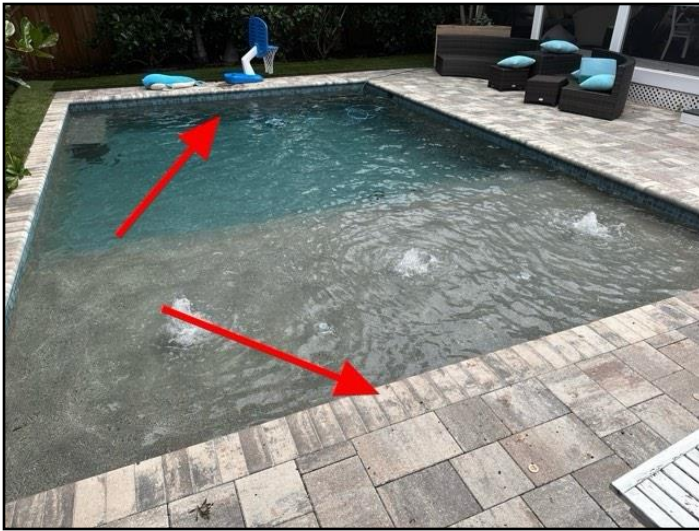
**44. Condition:** • Inoperative

Light should be repaired to ensure proper connection for pool electrical system. Recommend obtaining repair quote prior to closing as this replacement/repair can be costly.

**Task:** Repair, 4-POINT FAILURE
